# PROPERTY INSPECTION REPORT

**2320 Anywhere St, Los Angeles, CA, 90039**

**Inspector: Garrett Martell CMI**

**Date of Inspection: 6/6/2024**

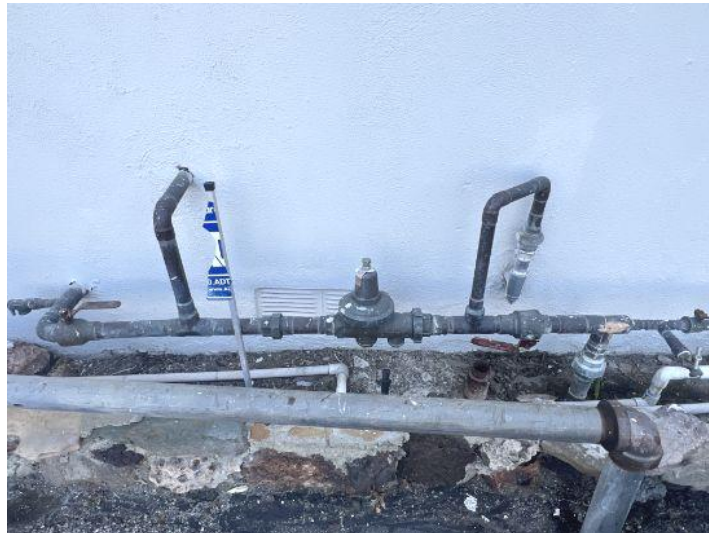
The main water shutoff is at the front of the building

Copper piping is viewed coming out of the ground by the building and as the main line runs underground from the street to the building, this appears to be the main water line.

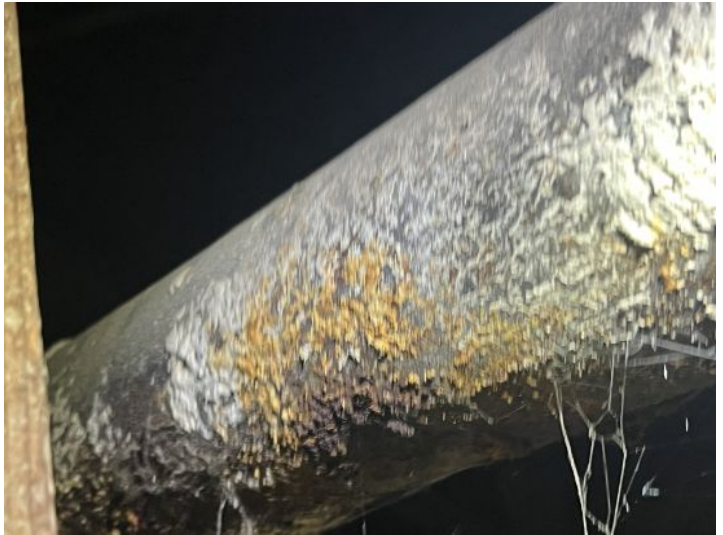
There are rusty areas on the exterior of the waste lines. It is not possible to tell when but they will need replacing in the future as they continue to wear out

Rust

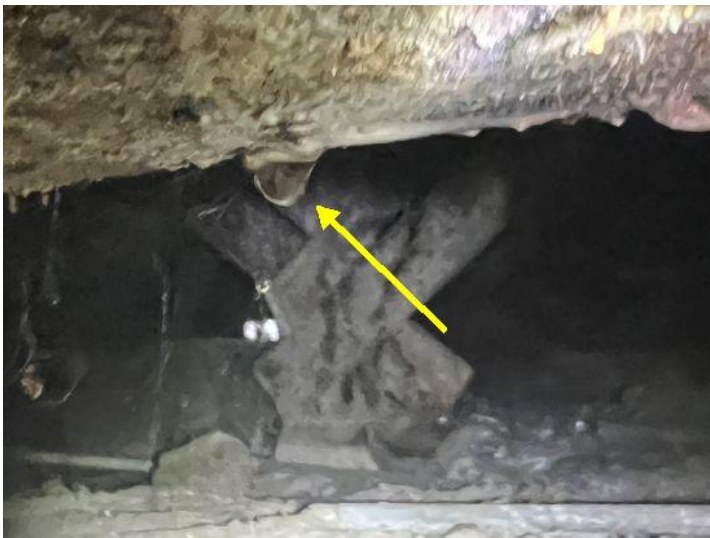
There are leaks in the waste pipes. These should be promptly repaired by a plumbing contractor

Leak - right crawlspace

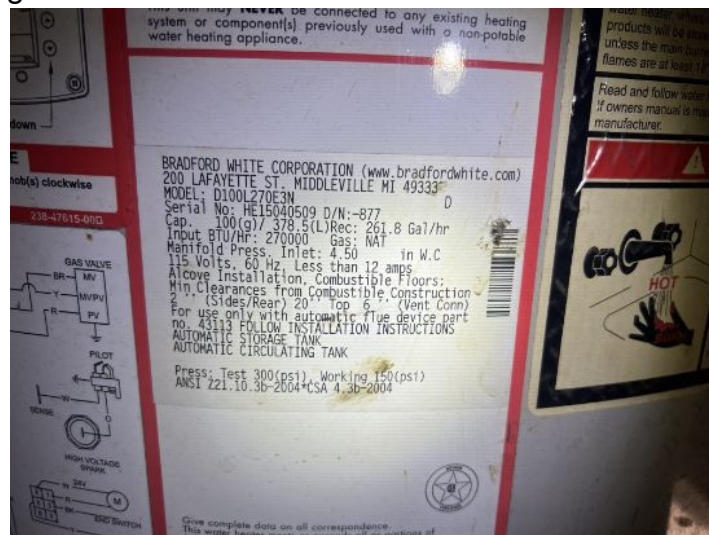
13 years old.

Manufactured 2011 / 100 gallon

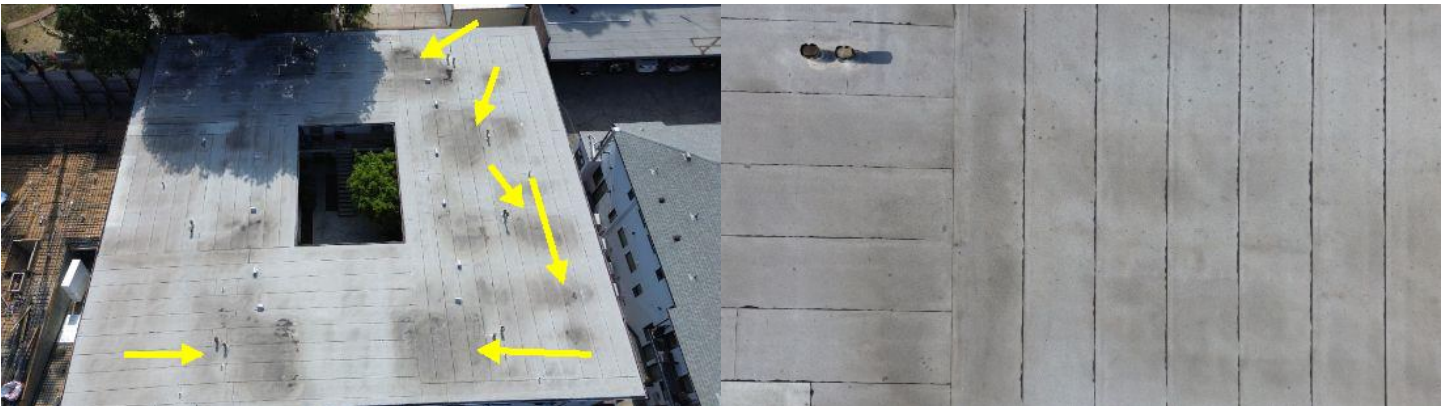
The roofing material is worn, deteriorating, and losing its granule surface. It is nearing the time to replace this roof.

There appear to be multiple layers of roofing material installed. When the current roof is ready to be replaced all old roofing materials need to be removed down to the wood framing, and then the new roof installed. The original framing may not have been rated for the extra weight of the roof coverings over the years. Also, the nails one get as much penetration as is needed due to the built-up thickness of the added layers.

Ponding occurs in areas as the roof is very flat

A licensed roofing contractor should examine the roof and make all needed repairs (or replacements) to ensure a long lasting leak free condition. The roofing contractor is the specialist in this area and that is why it is being referred so they can determine all the problems and give an accurate estimate of the costs involved

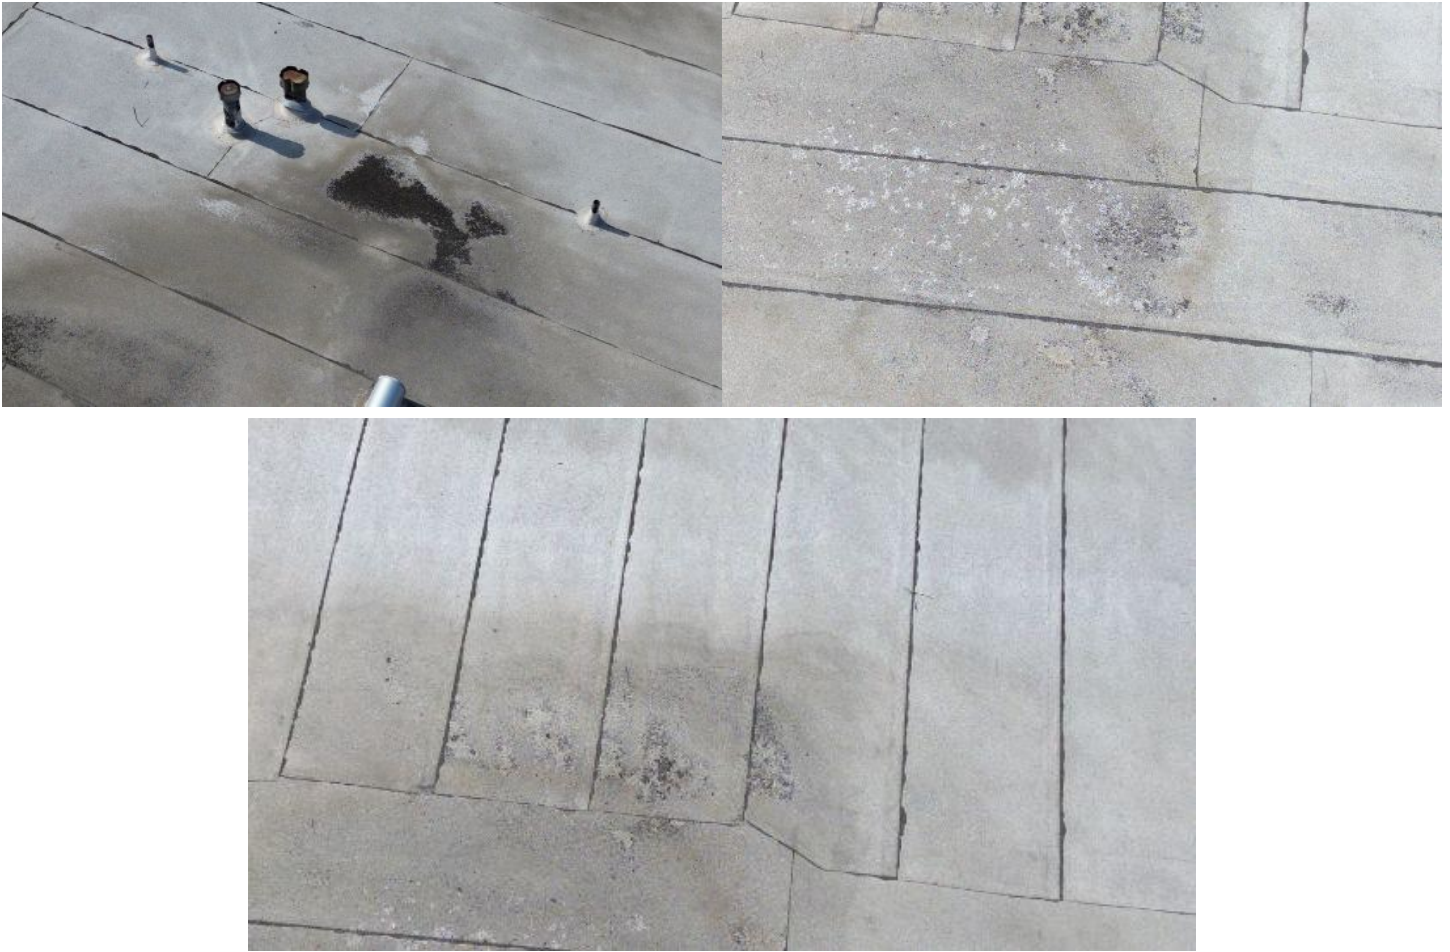
Patching

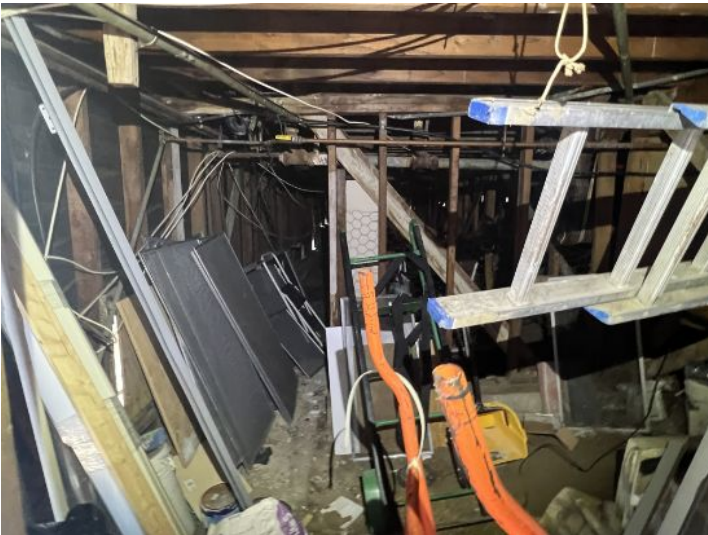
Left side crawlspace

There are areas of damp soil under the building

Rodent droppings were observed in the crawl space. It is advised to have a specialist in this area examine the structure and property to determine the presence or not of any infestation and recommend any corrective measures.

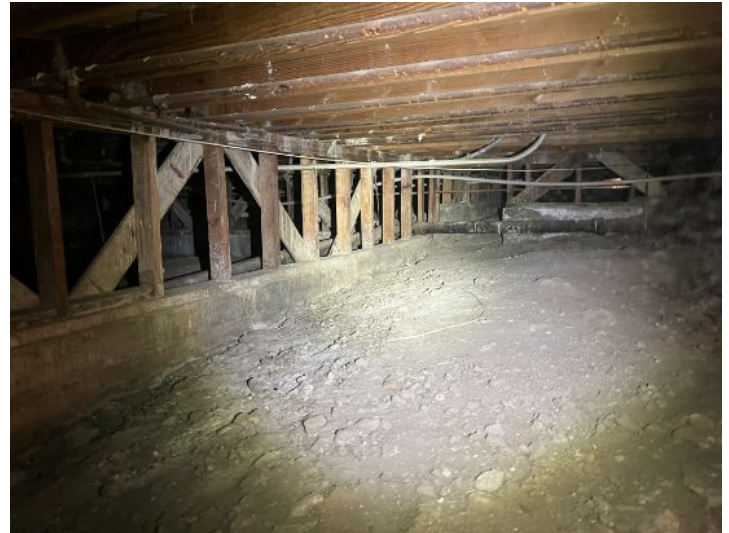
Wet area

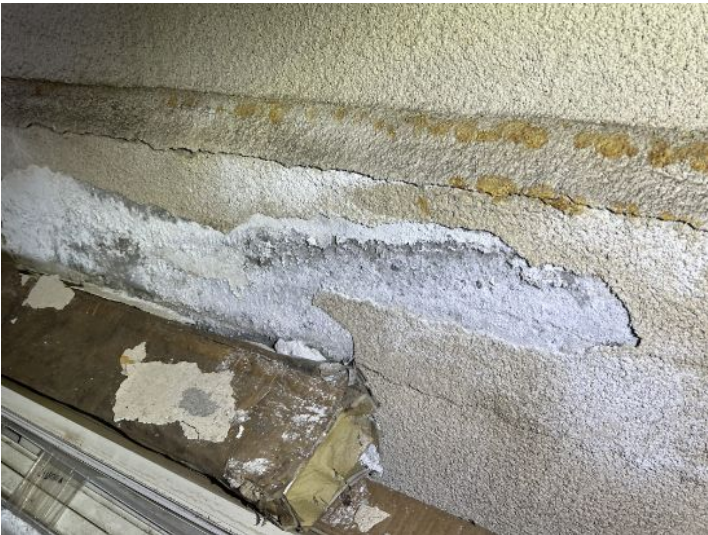
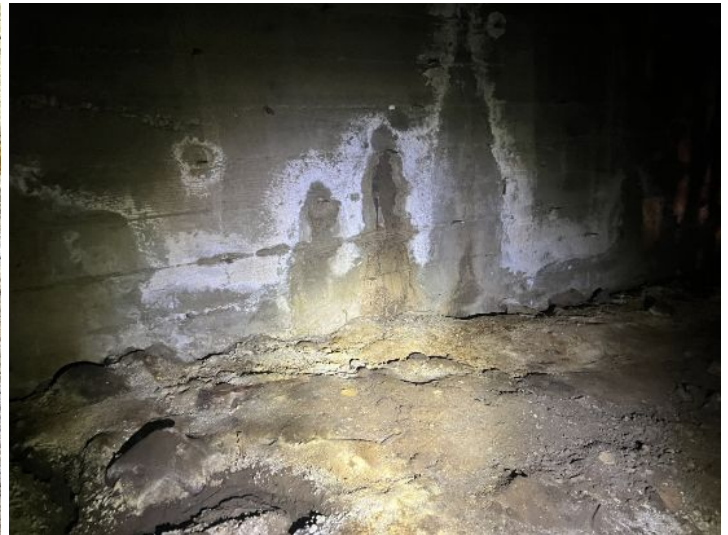
There are chalky areas on the concrete. These are an indication that water has entered the concrete and crawl space during wet weather and brought salts out of the concrete when it came to the surface.

Efflorescence

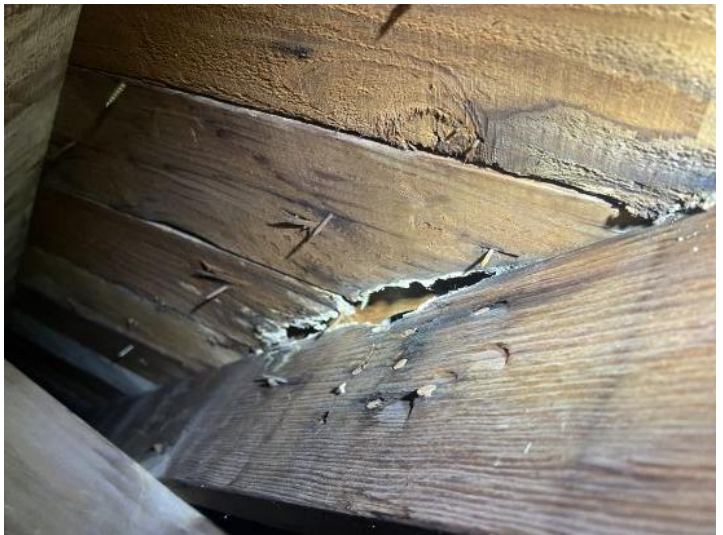
There are damaged and deteriorated areas of floor framing.

Deterioration

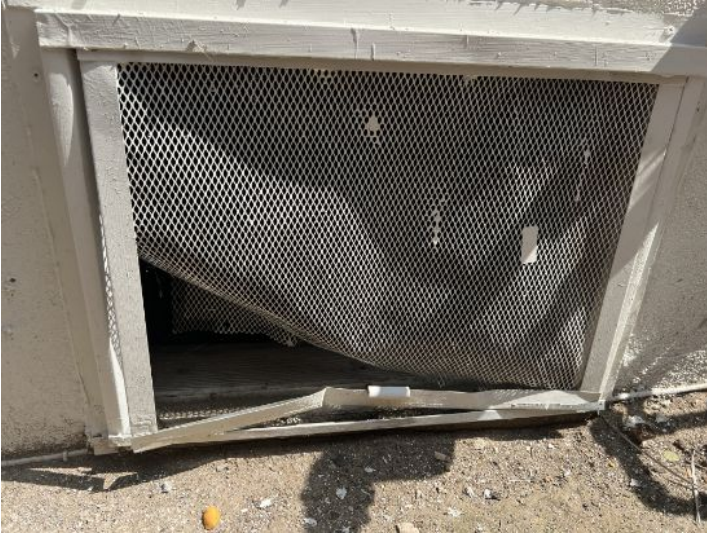
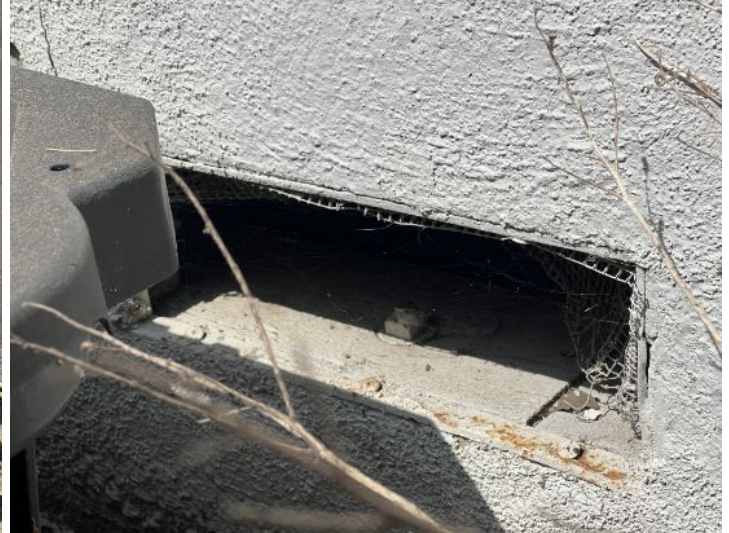
The access cover to the crawl space is damaged and needs to be repaired or replaced

There are damaged fresh air vent screens. This may allow animals or insects to enter

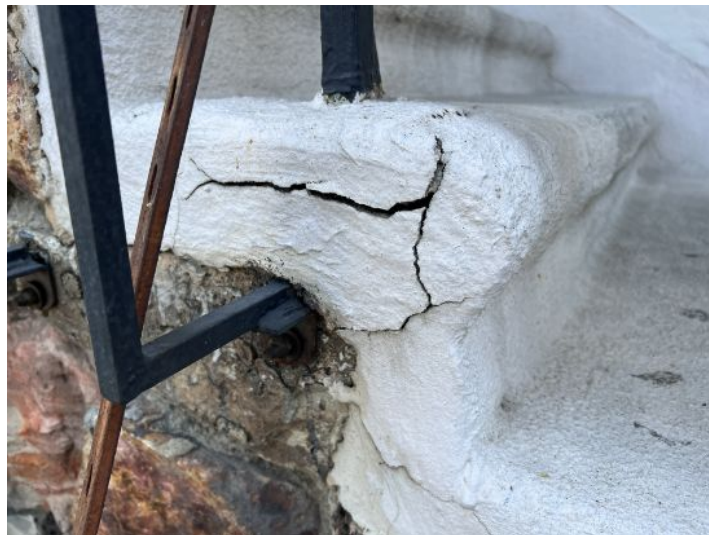
**The stairs are damaged in areas.**

Entry stairs

Repairs for the walkways and front stairs should be planned for now as the time is short and demand for contractors is increasing

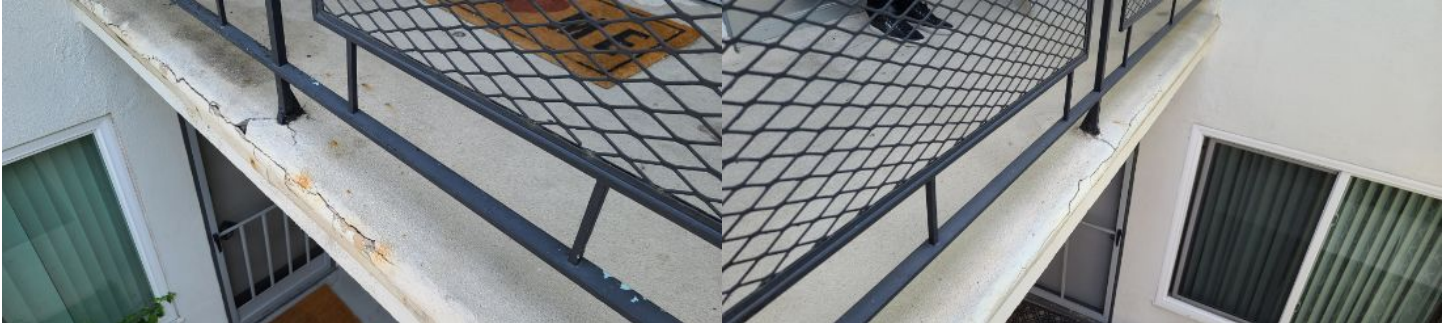
There is damage to the surface where the railing attaches to the deck and along the edges

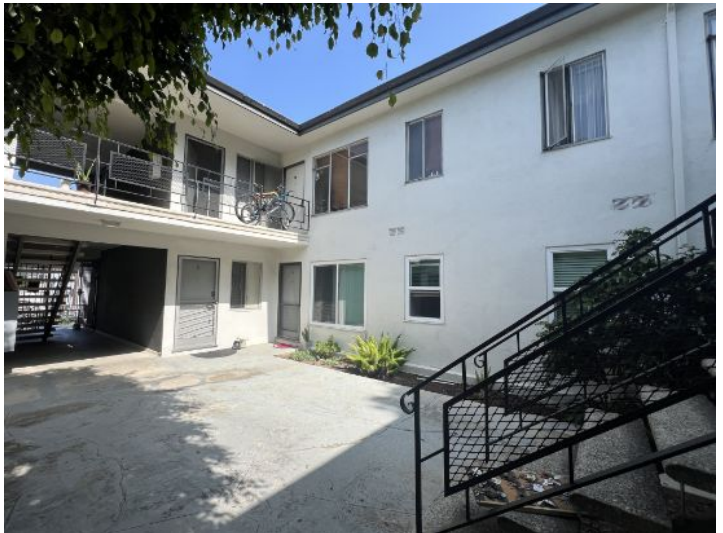
Courtyard area. Please refer to drainage noted

There is no drainage in the courtyard. There are areas where the courtyard is not level, and will hold water. It is recommended to have drainage installed in this area.

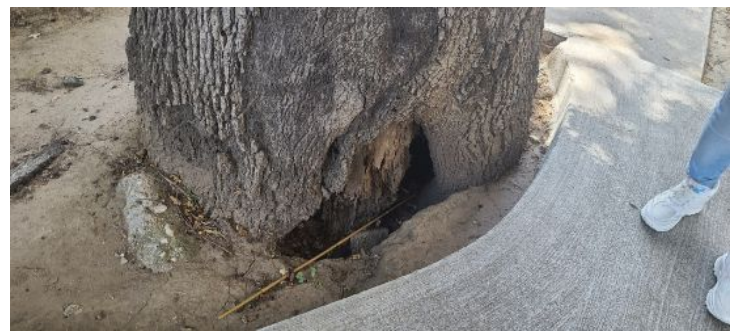
There are trees planted close to the structure with branches that are overhanging/close to the roof. These may need to be trimmed back at times.

The tree is old and deteriorated. Consult an arborist

Trees close roof:

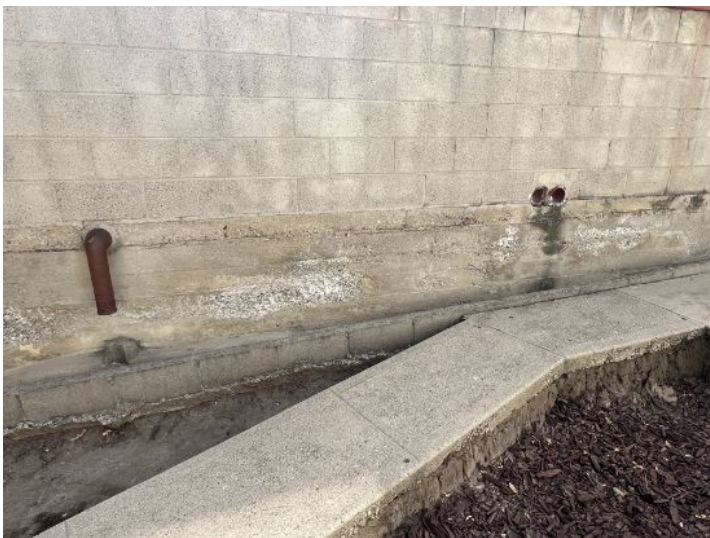
There are below grade drains in use on the property. These need to be checked and cleaned periodically to ensure they are functioning as they should.

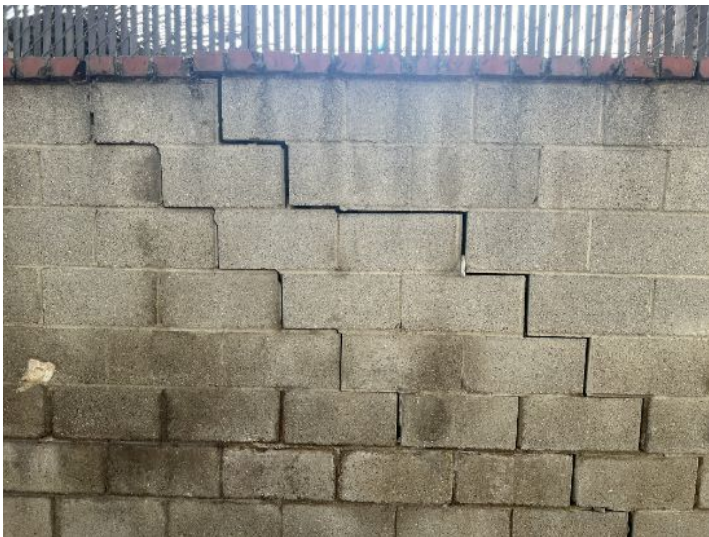
The block fence at the rear is leaning.

Step cracking

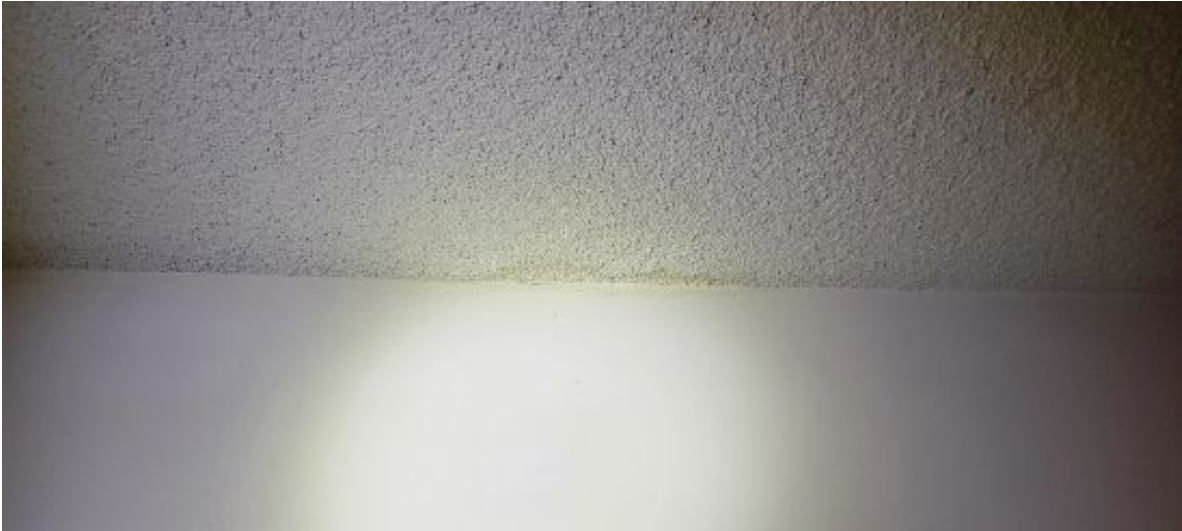
There are areas of stains on the ceiling in the living room

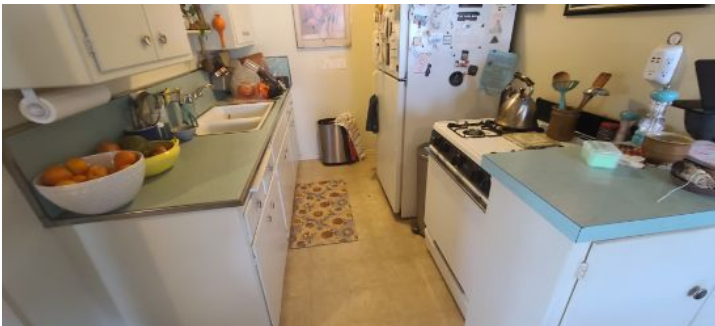
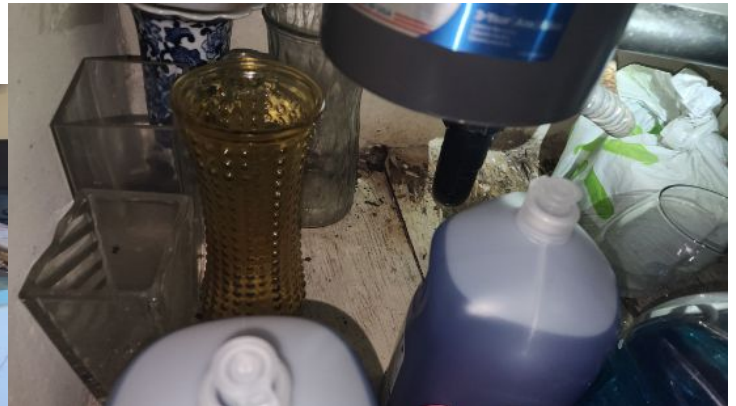
The cabinet area below the sink has damage/deterioration which appears to have been caused by moisture.

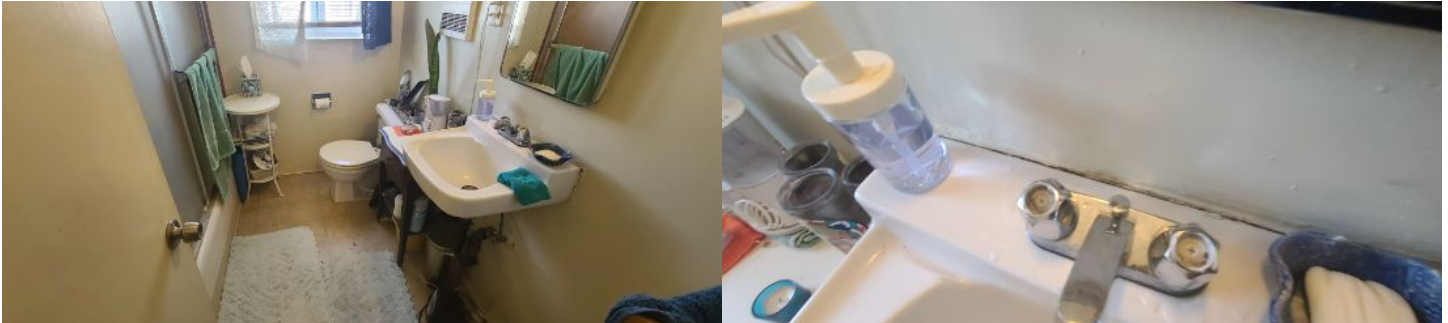
Loose

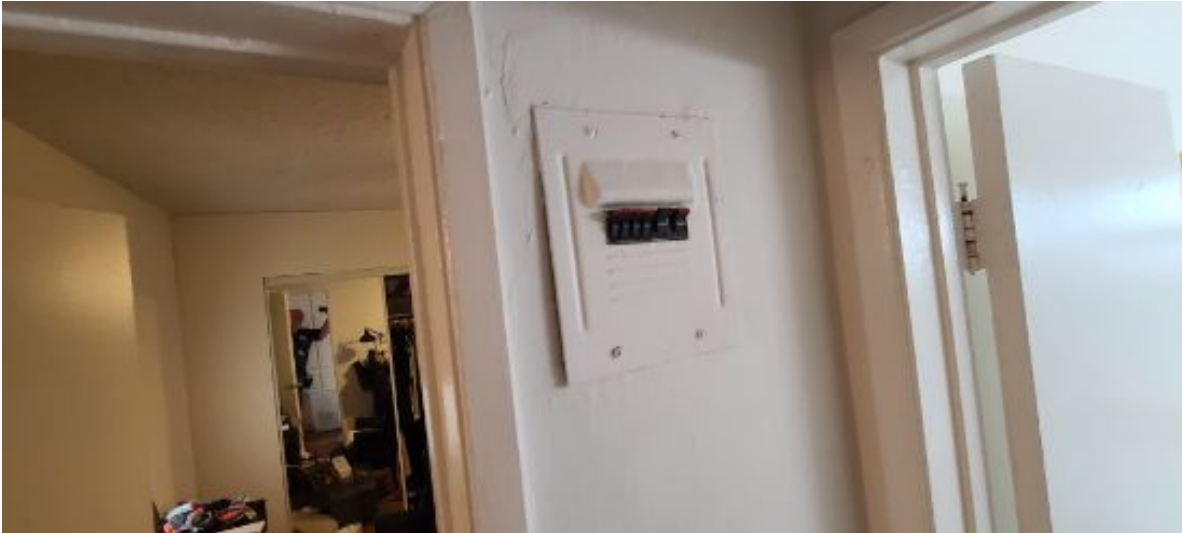
This panel is an older Federal Pacific system which have been known to have breakers that fail to trip properly when compared with similar panels of the same age and considered a potential fire safety concern, further evaluation is recommended by a licensed electrician to that any repairs or replacements may be made

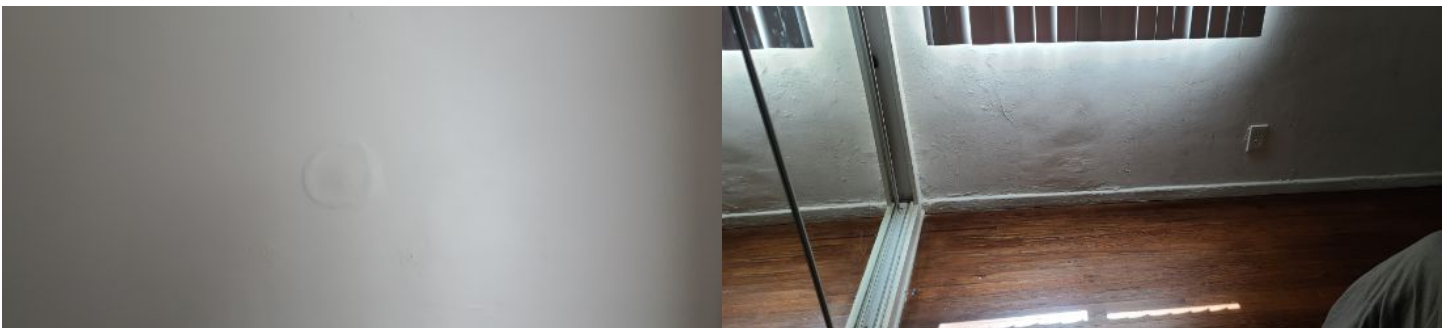
**There are areas of damage on the ceiling**

**There are areas of damage on the walls**

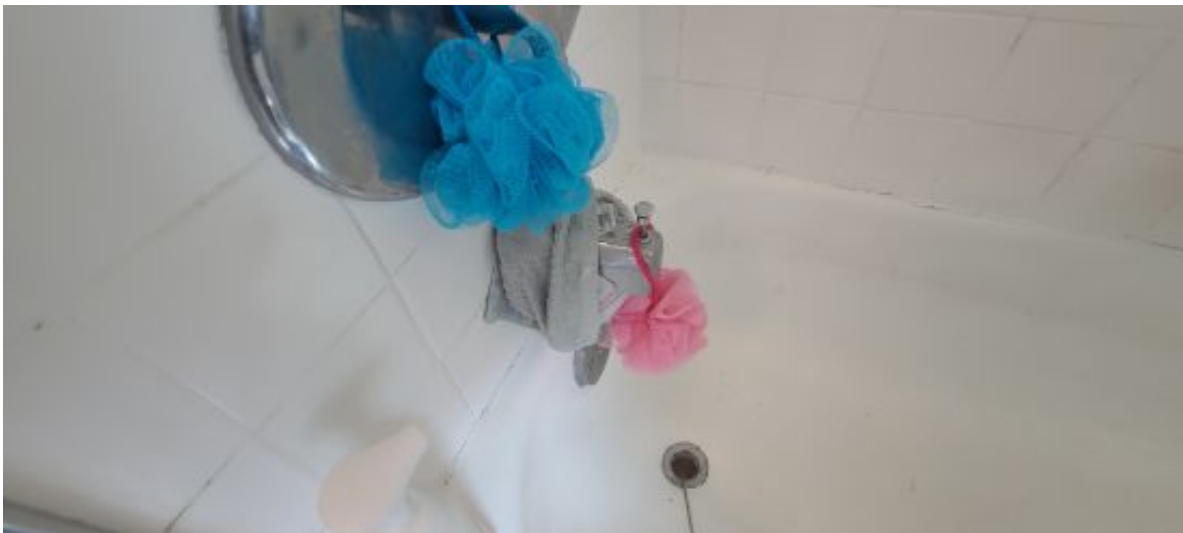
The diverter is stuck

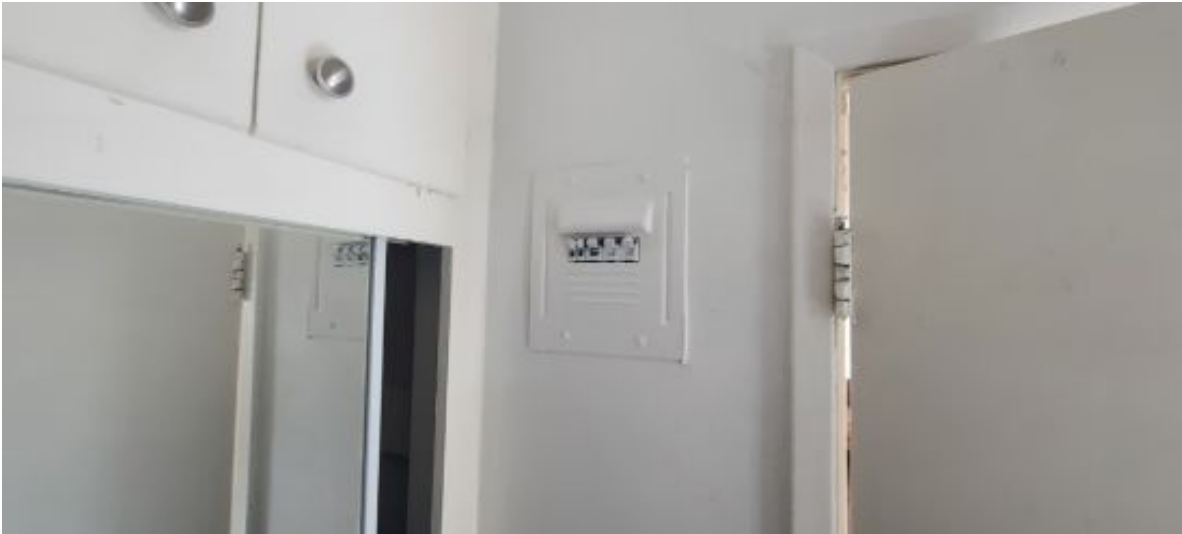
This panel is an older Federal Pacific system which have been known to have breakers that fail to trip properly when compared with similar panels of the same age and considered a potential fire safety concern, further evaluation is recommended by a licensed electrician to that any repairs or replacements may be made

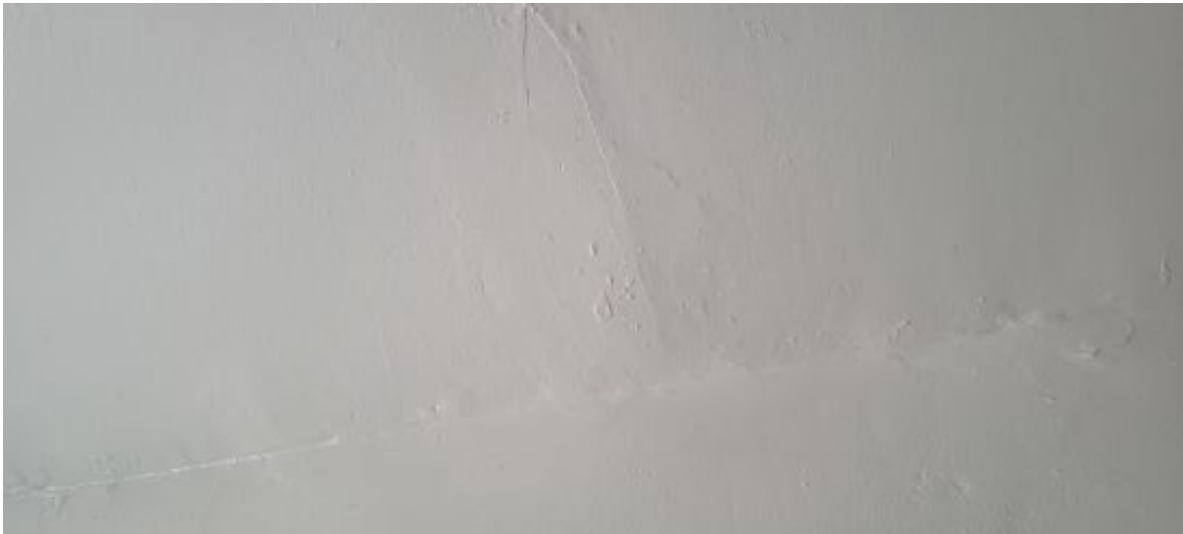
There are areas of stress cracks in the walls

There are areas of stress cracks in the ceiling

There are areas of past patching and painting. The seller could be consulted.

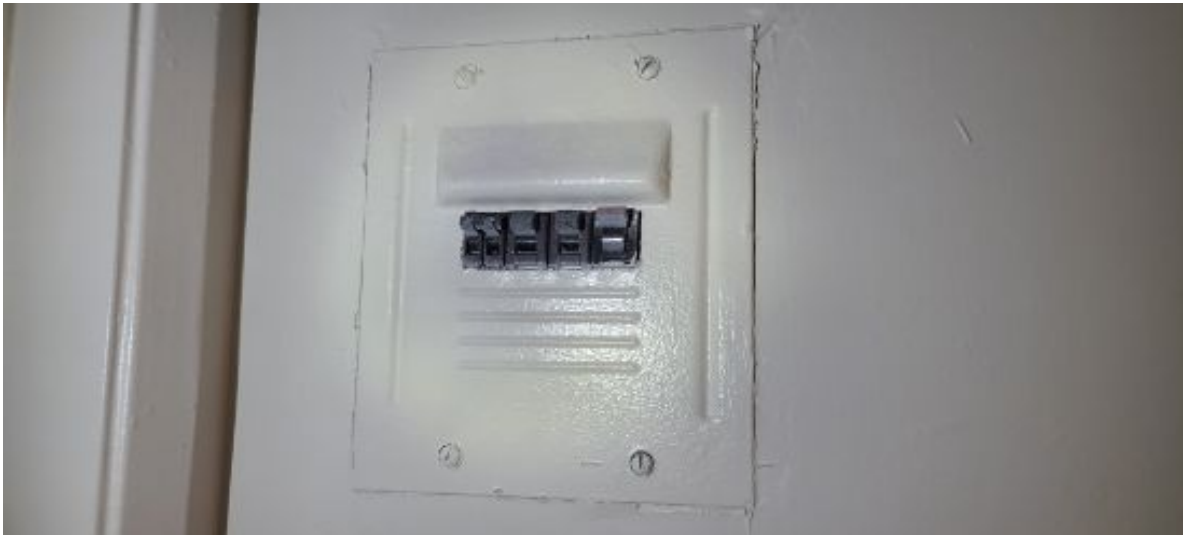
This panel is an older Federal Pacific system which have been known to have breakers that fail to trip properly when compared with similar panels of the same age and considered a potential fire safety concern, further evaluation is recommended by a licensed electrician to that any repairs or replacements may be made

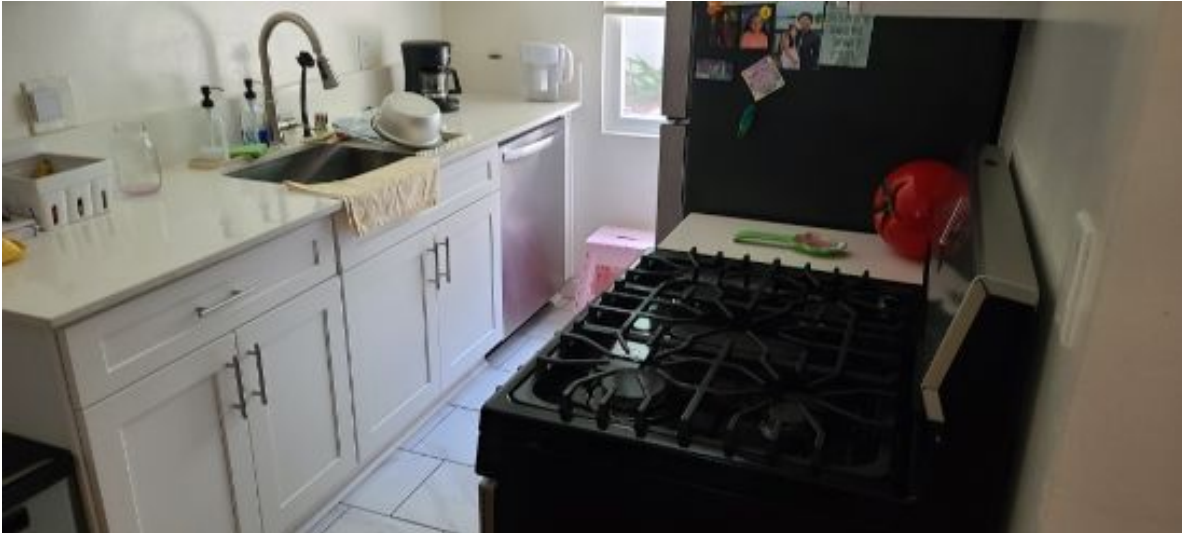
The cabinet area below the sink has damage/deterioration which appears to have been caused by moisture.

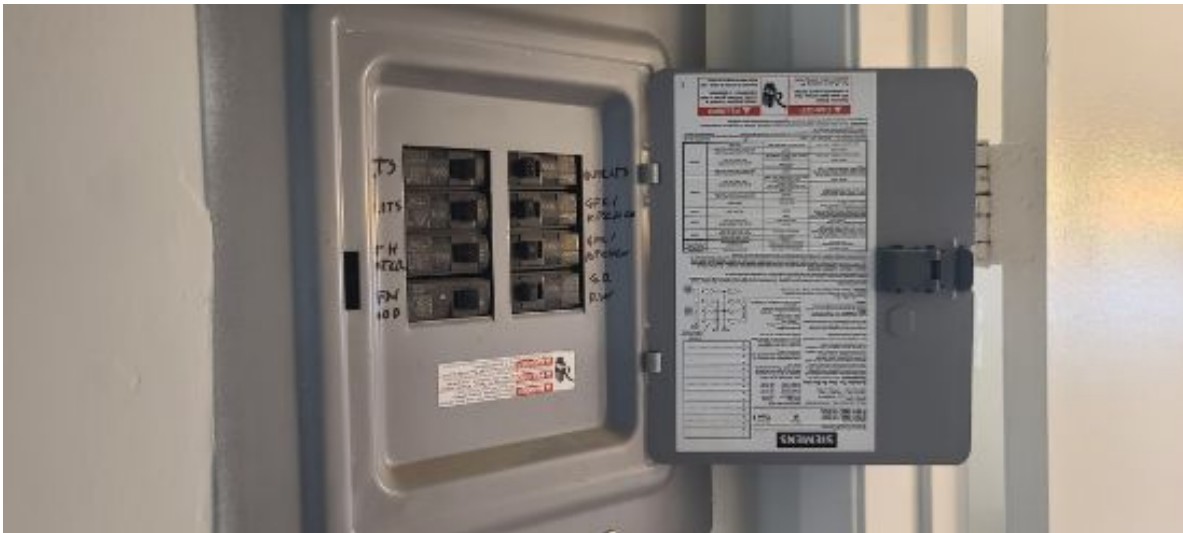
This is a newer sub panel.

This panel is an older Federal Pacific system which have been known to have breakers that fail to trip properly when compared with similar panels of the same age and considered a potential fire safety concern, further evaluation is recommended by a licensed electrician to that any repairs or replacements may be made

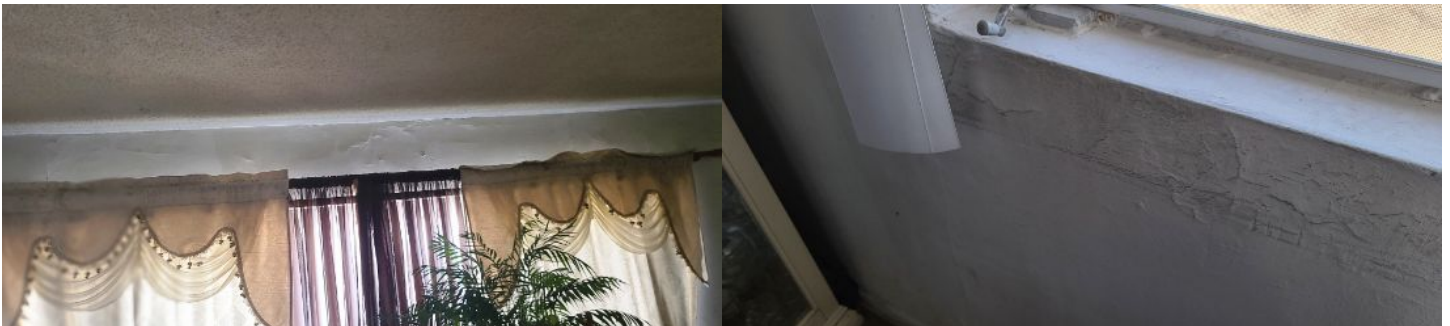
There are areas of damage on the walls

There are areas of stains on the ceiling

There are areas of past patching and painting. The seller could be consulted.

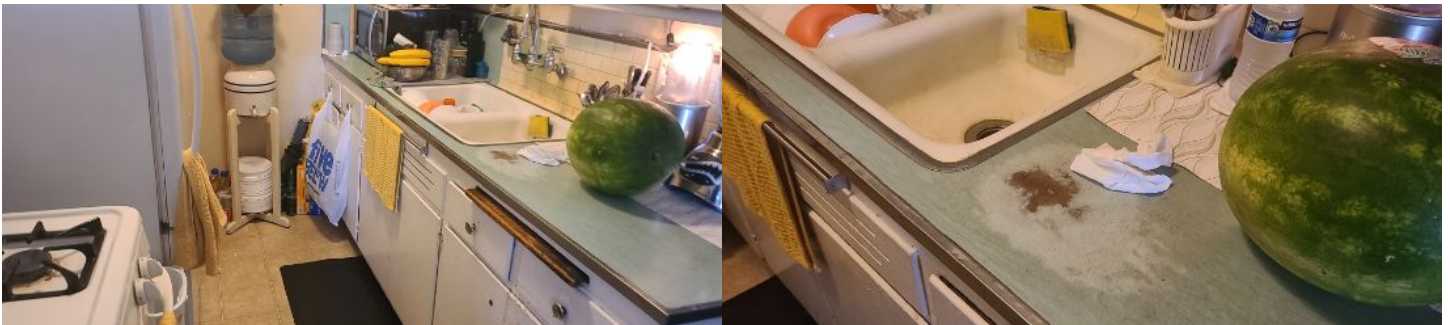
There are areas of wear to the cabinets.

The cabinet area below the sink has damage/deterioration which appears to have been caused by moisture.

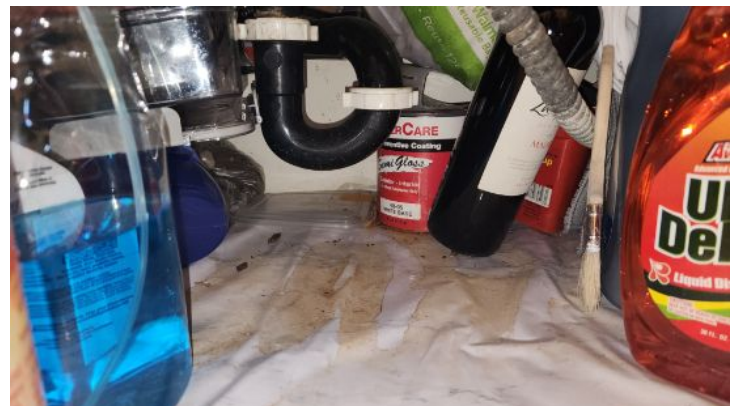
Drain leaks

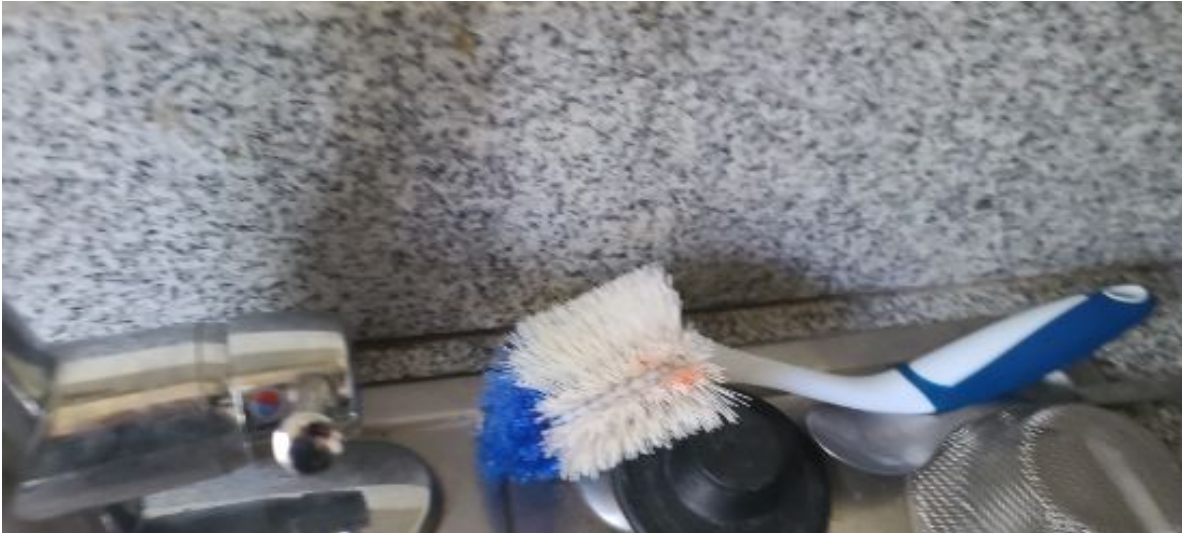
There are areas of damage to the cabinets.

The cabinet area below the sink has damage/deterioration which appears to have been caused by moisture.

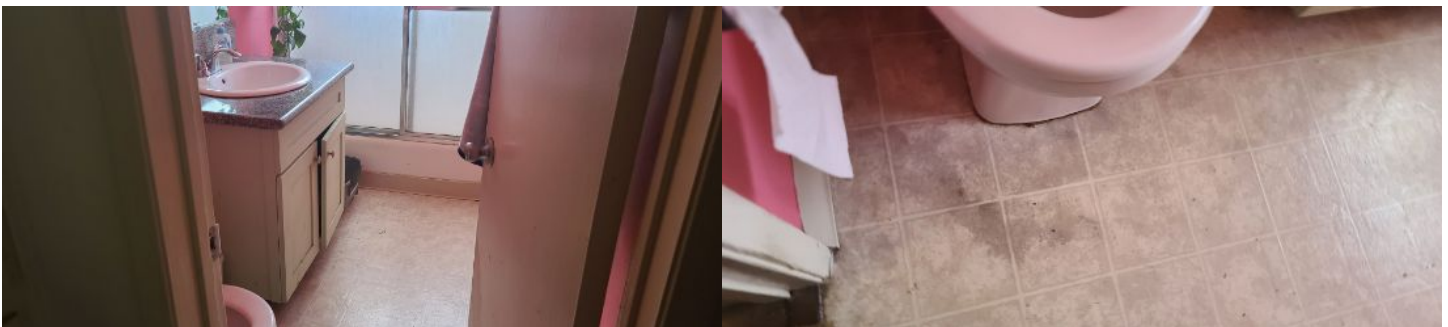
The bathroom flooring is stained in areas

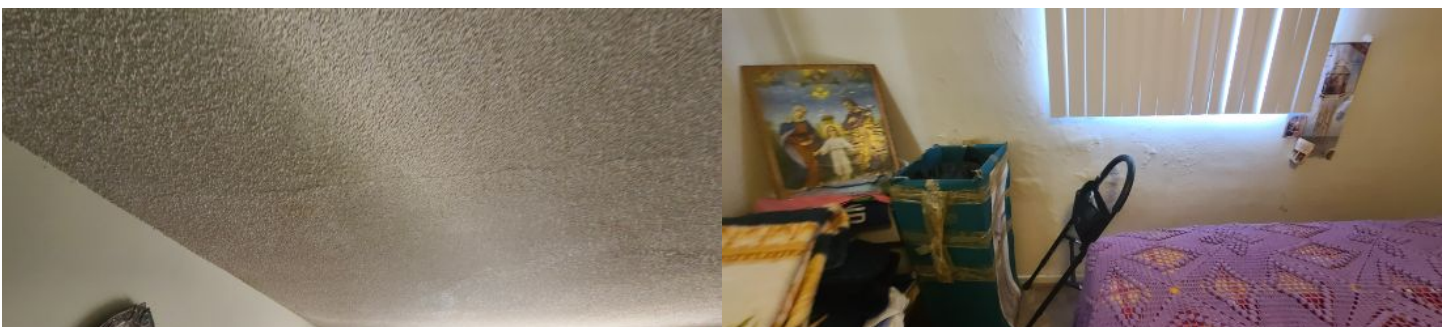
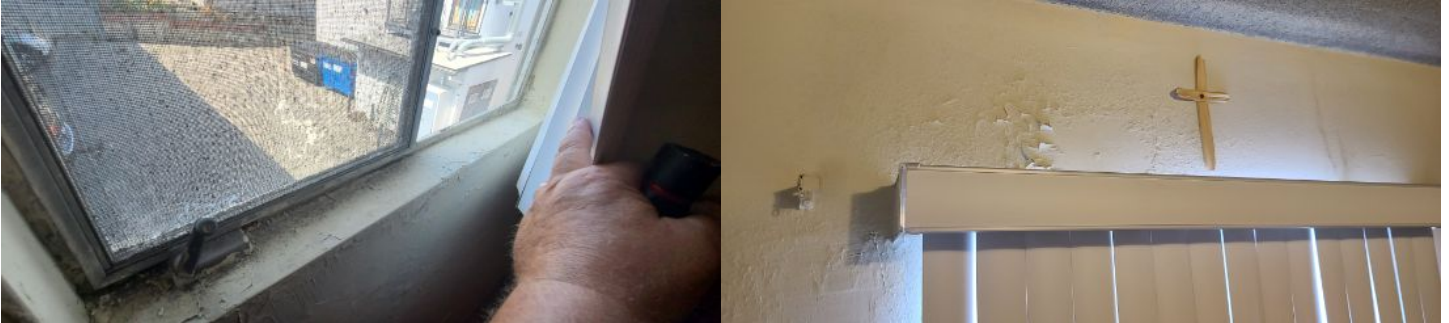
There are areas of damage on the ceiling

There are areas of damage on the walls

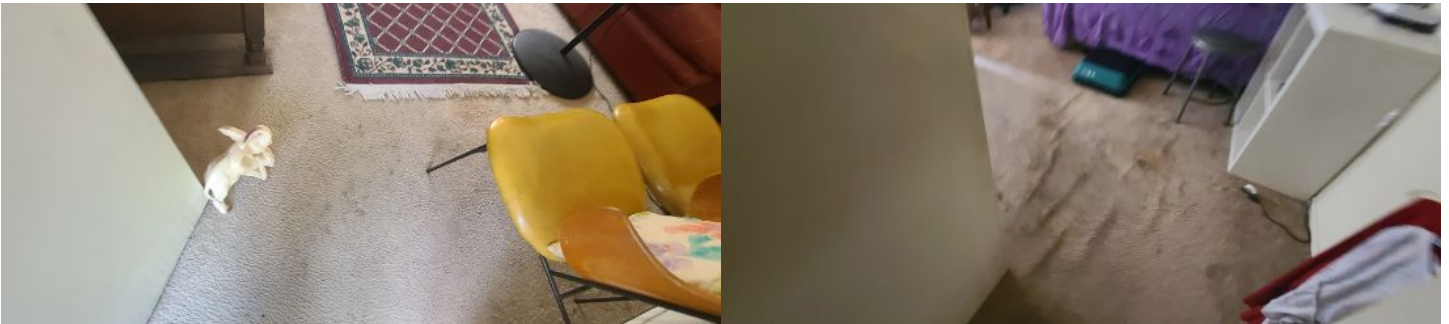
The carpet is worn/stained in areas.

The carpeting is loose in areas.

The carpet is damaged in areas.

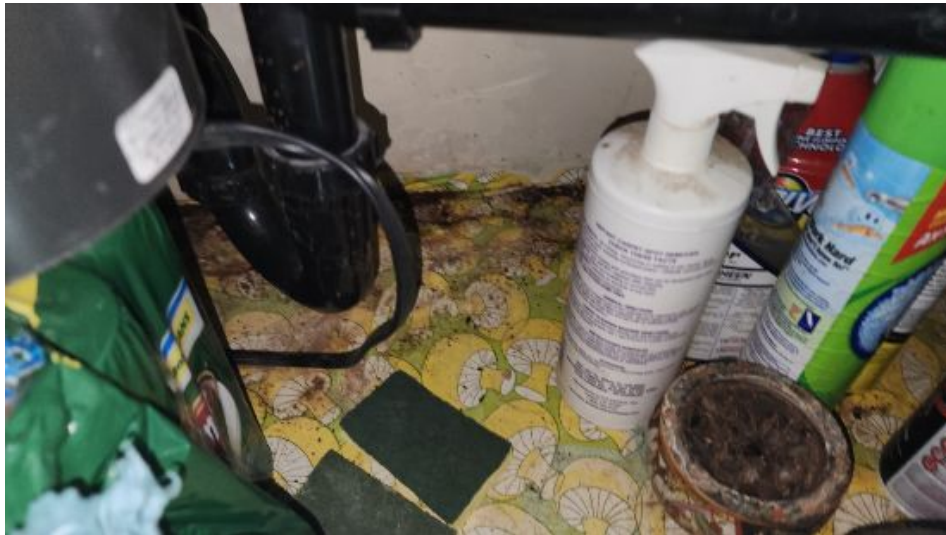
There are areas of wear to the cabinets.

The cabinet area below the sink has damage/deterioration which appears to have been caused by moisture.

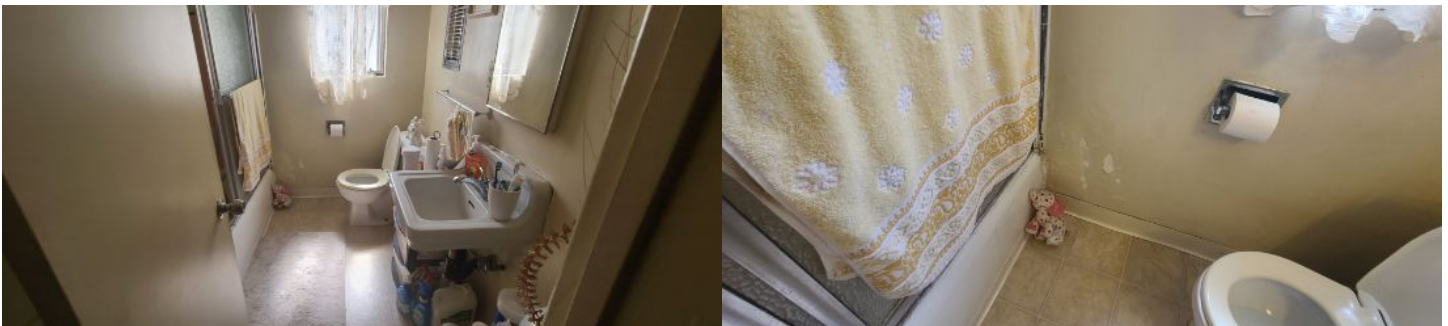
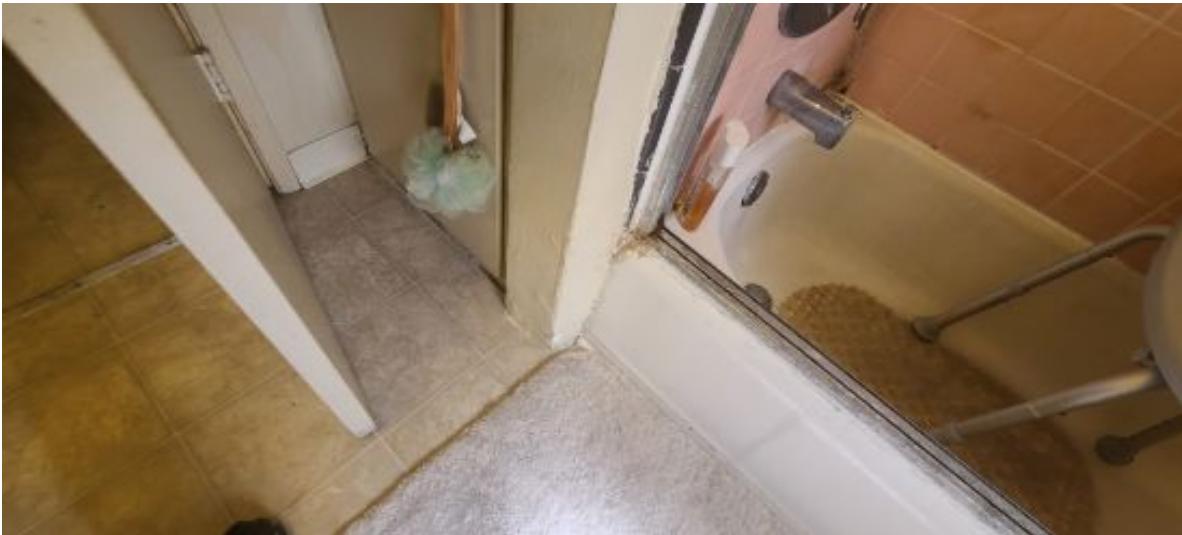
There are areas of moisture deterioration at the ceiling

There are areas of moisture deterioration at the wall surfaces.

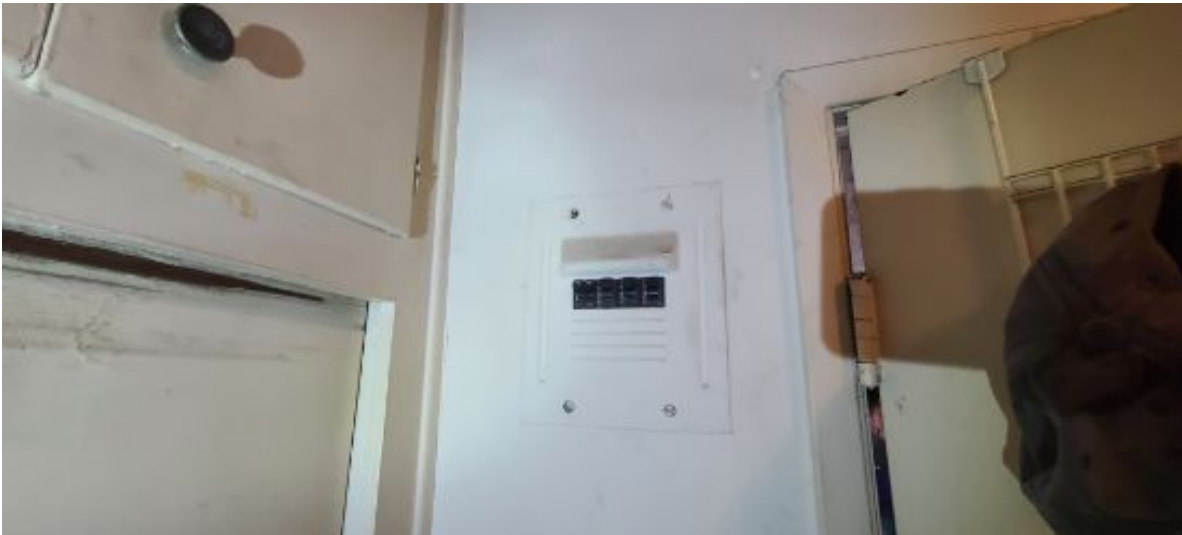
This panel is an older Federal Pacific system which have been known to have breakers that fail to trip properly when compared with similar panels of the same age and considered a potential fire safety concern, further evaluation is recommended by a licensed electrician to that any repairs or replacements may be made
