# PROPERTY INSPECTION REPORT

**2320 Anywhere St, Los Angeles, CA, 90039**

**Inspector: Garrett Martell CMI**

**Date of Inspection: 6/6/2024**

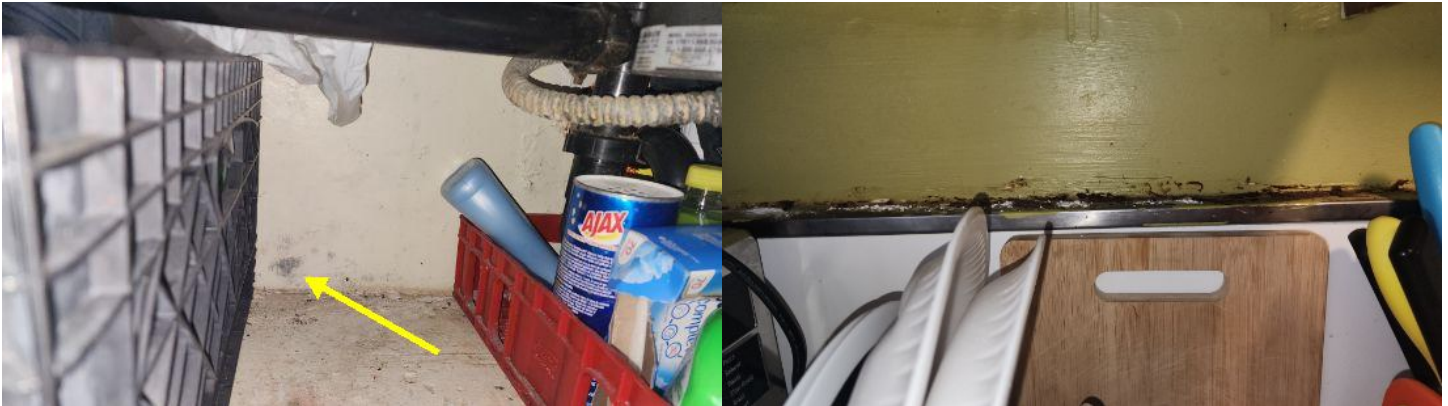
There are areas of wear to the counter.

Likely mold

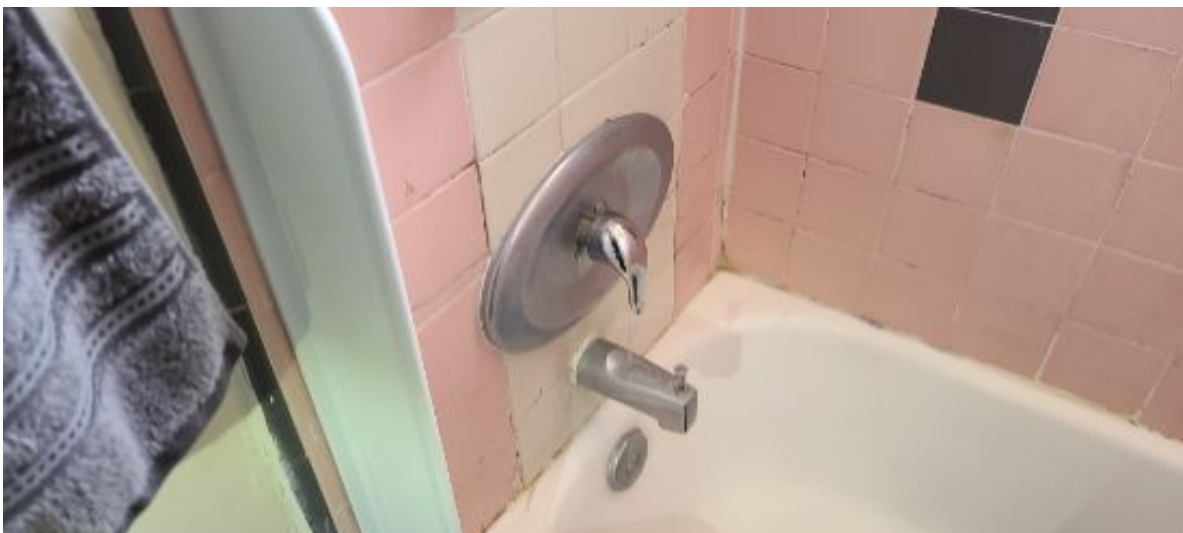
Shower walls are worn

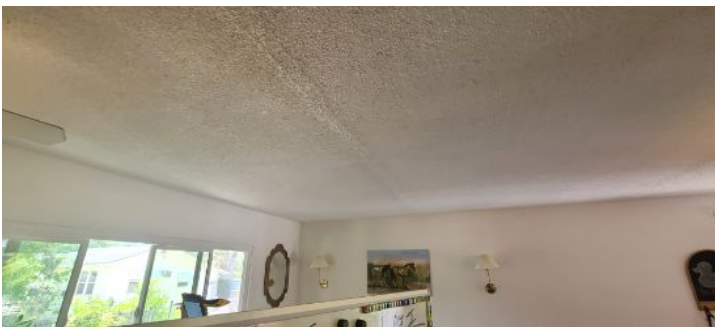
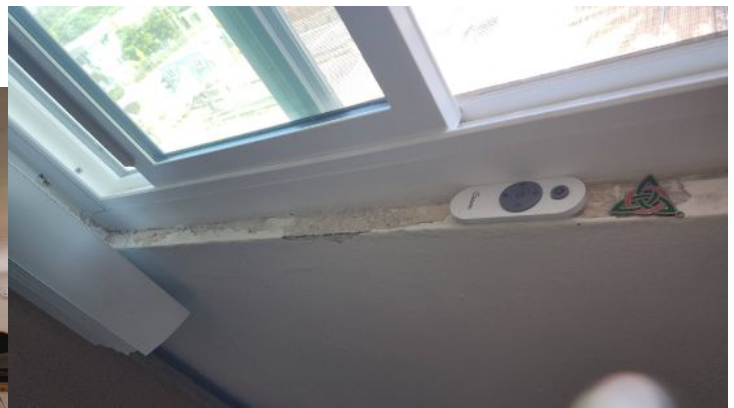
There are areas of damage on the walls

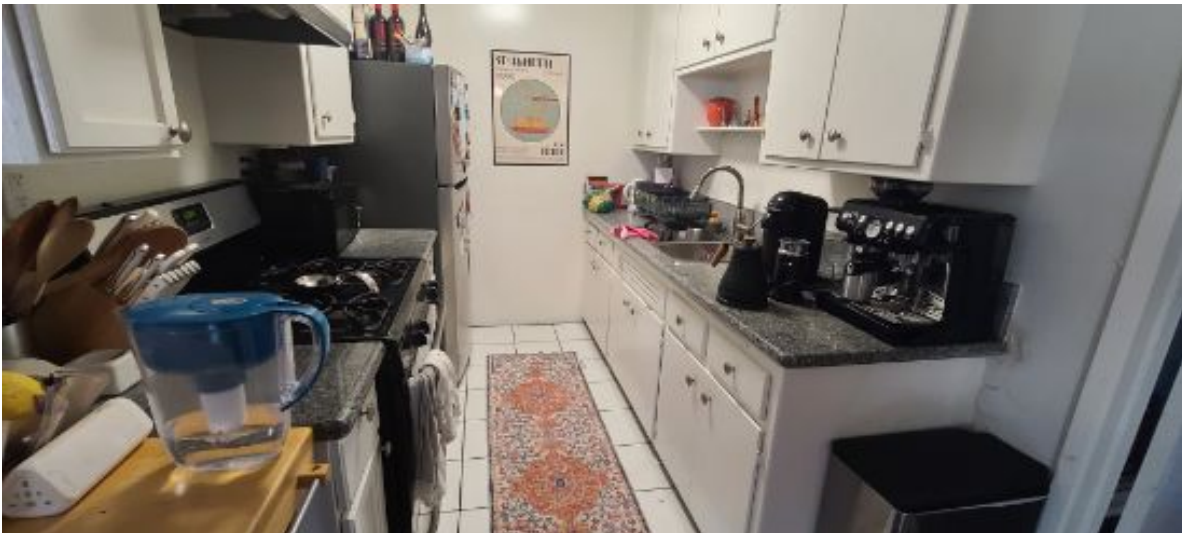
The cabinet area below the sink has damage/deterioration which appears to have been caused by moisture.
