# PROPERTY INSPECTION REPORT

**3744 Main St, Tarzana, CA,**

**Inspector: Garrett Martell CMI**

**Date of Inspection: 5/31/2024**

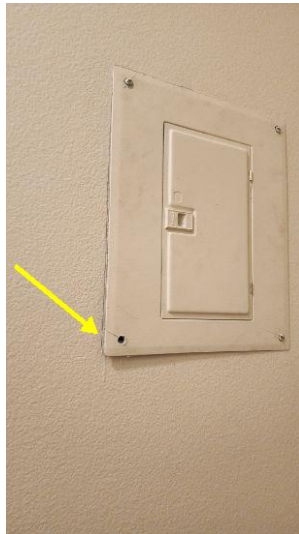
Missing screw

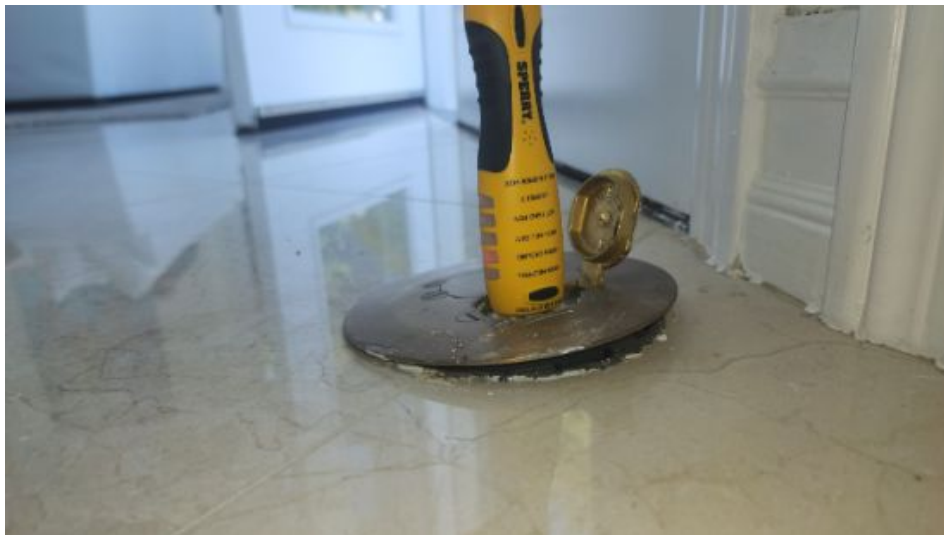
Living room

No ground in the floor outlet. This outlet is also loose.

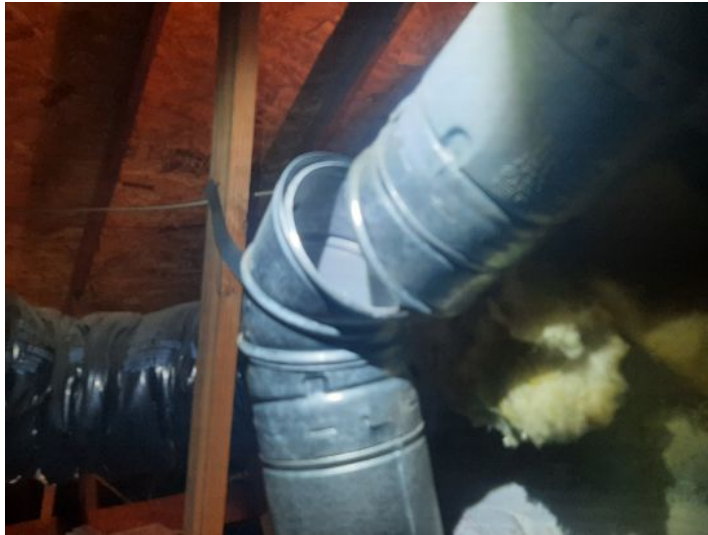
The vent line is disconnected and exhaust gases from the furnace are escaping. This is a safety hazard and needs to be corrected.

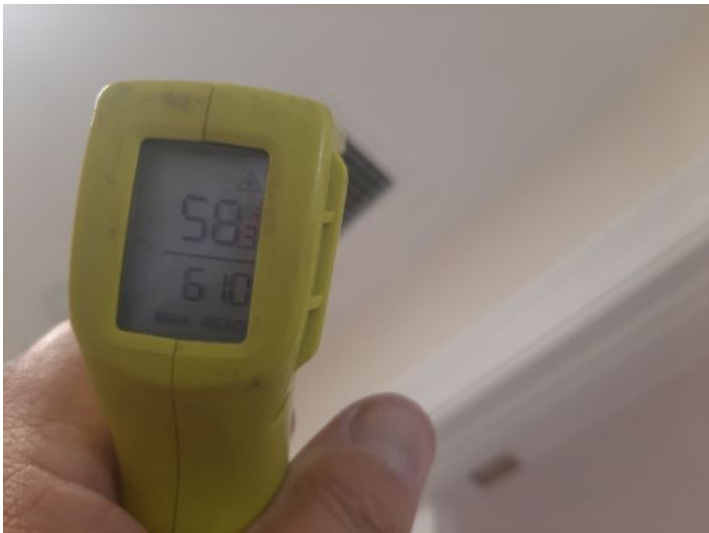
Supply air

The air coming out of the unit is somewhat cool and has less than the expected temperature difference between the return air and the cooled air. This is not cooled enough to be considered functioning properly. There should be a 15–20 degree temperature differential between the air return and the cool air coming out of the grills throughout the home. The air conditioner is not working at full strength and should be evaluated and serviced by a licensed HVAC technician to determine the reason this is occurring.

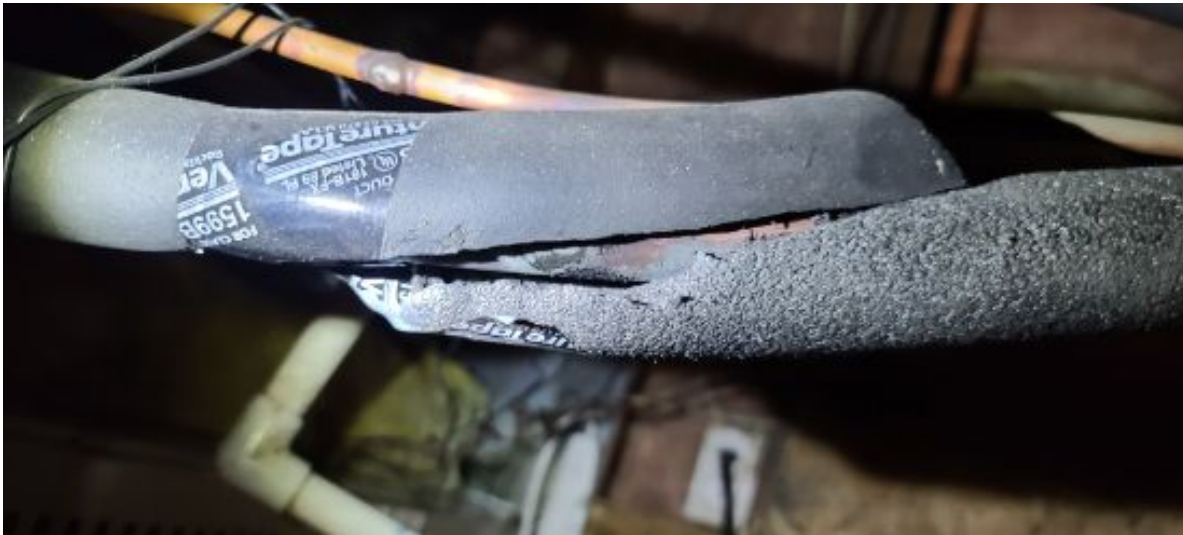
Damaged insulation needs repair.

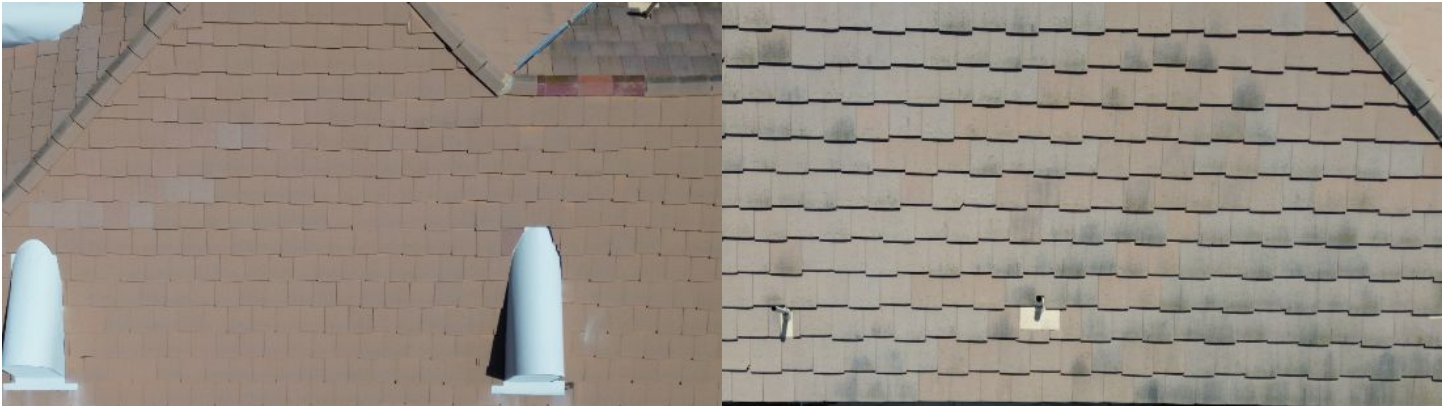
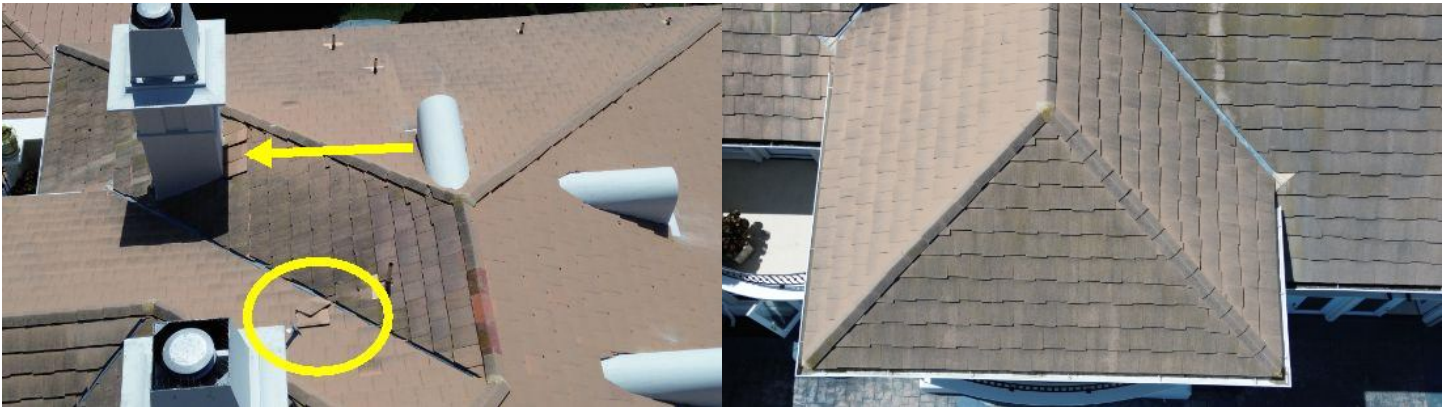
Displaced tiles

There are displaced tiles that have slipped down and are no longer in the correct location. This allows sunlight to deteriorate the exposed underlayment. These should be repaired.

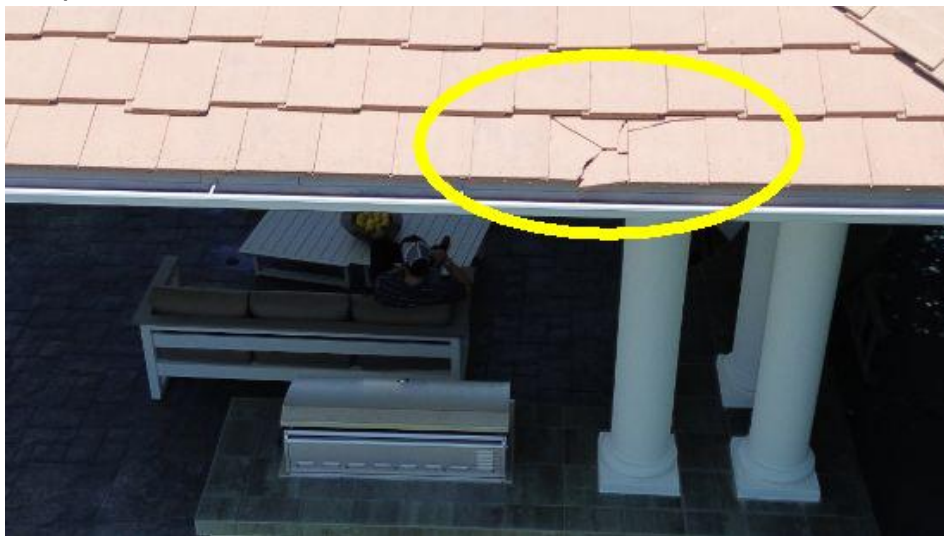
**There are areas of cracked tiles. This allows sunlight to deteriorate the exposed underlayment. These should be repaired.**

Cracked tile - over covered patio

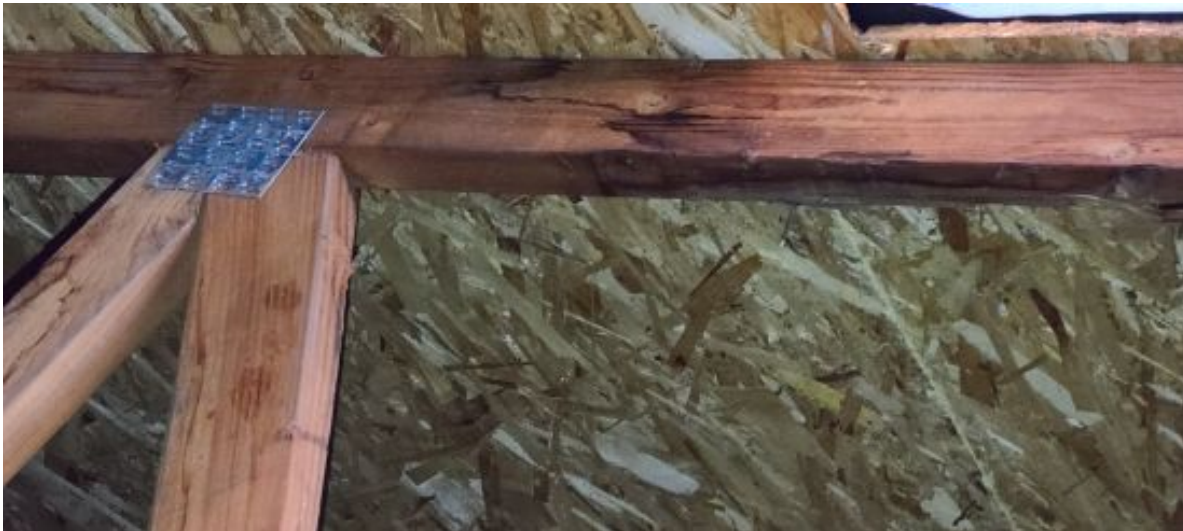
There are areas of moisture stains on the framing lumber. These are common in attics and may indicate past leaks.

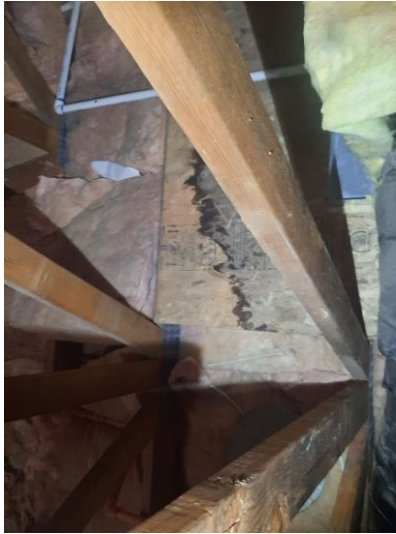
Staining on the floor near the rear furnace.

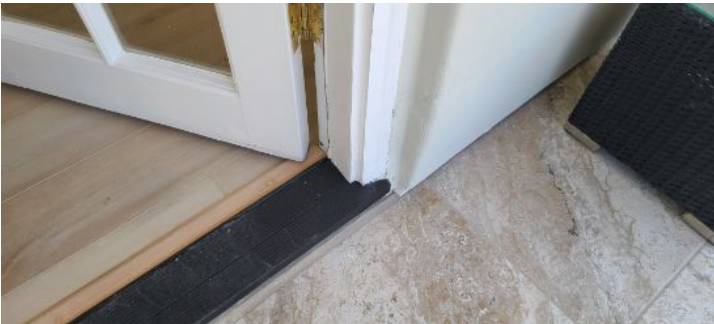
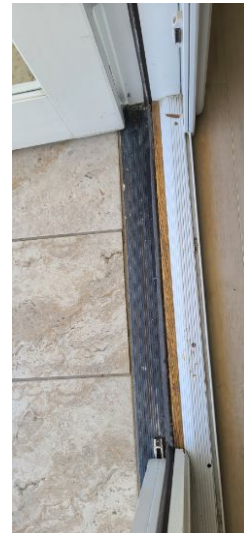
Weatherstripping to the door needed at the front upper bedroom

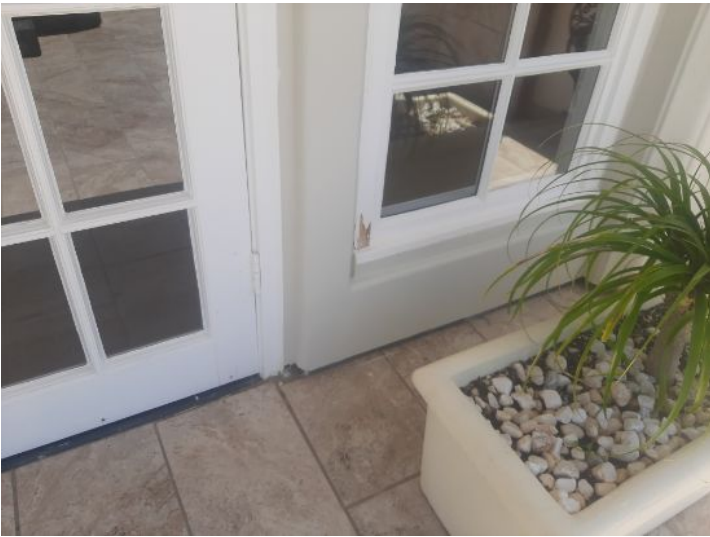
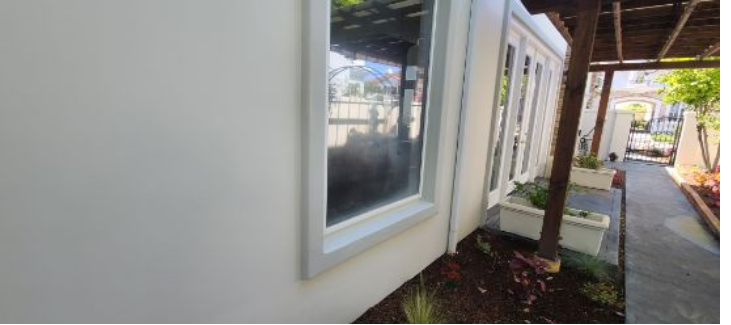
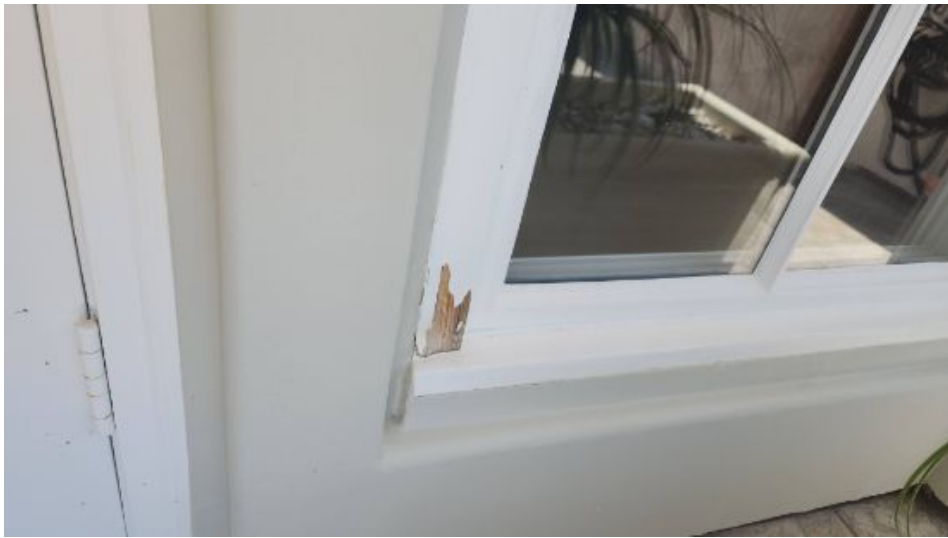
**There are windows with condensation between the panes of glass in the dual glazed window. There is no repair for this other than replacing the sealed unit.**

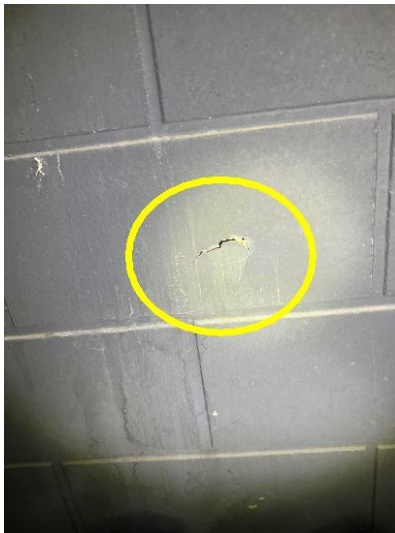
There is some damage in the panel and repairs may be needed.

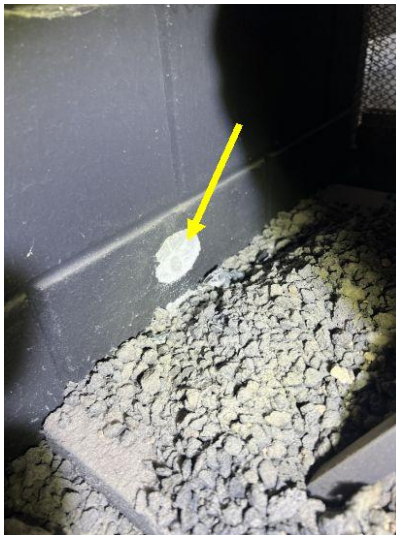
A gas line hole was patched in the past.

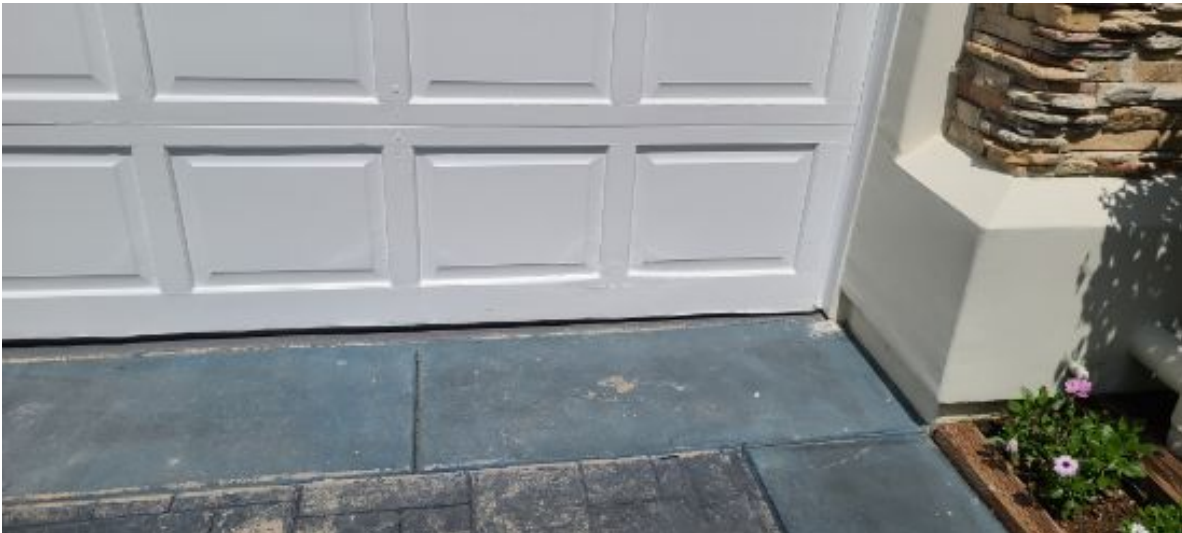
There is some deterioration to the bottom panel

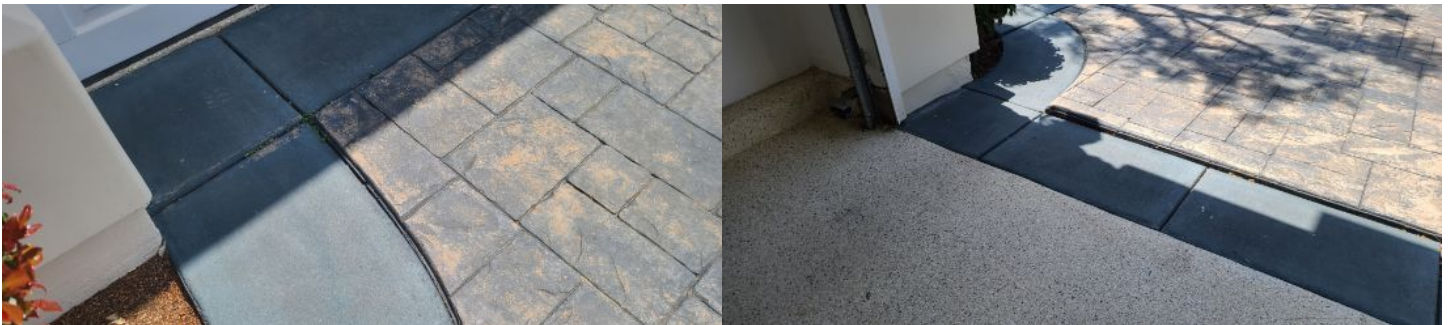
**There are tree root systems causing shifting and cracking of the driveway in areas.**

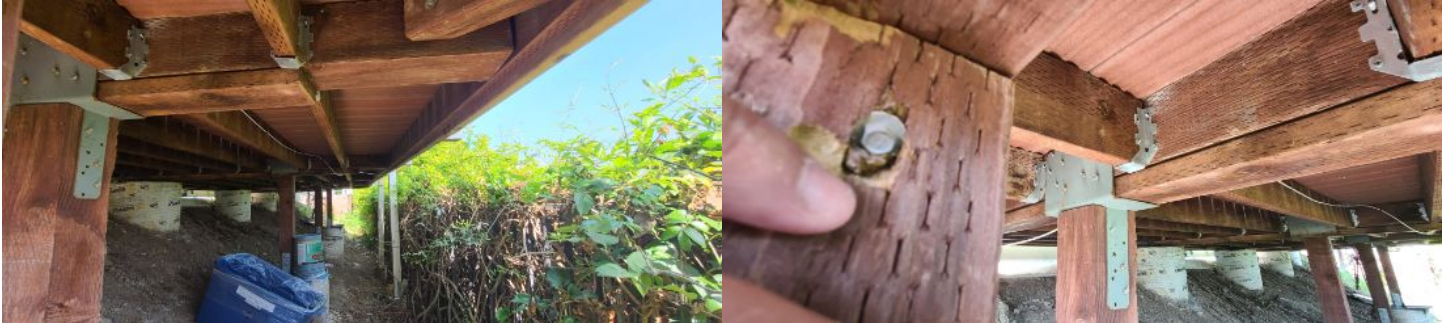
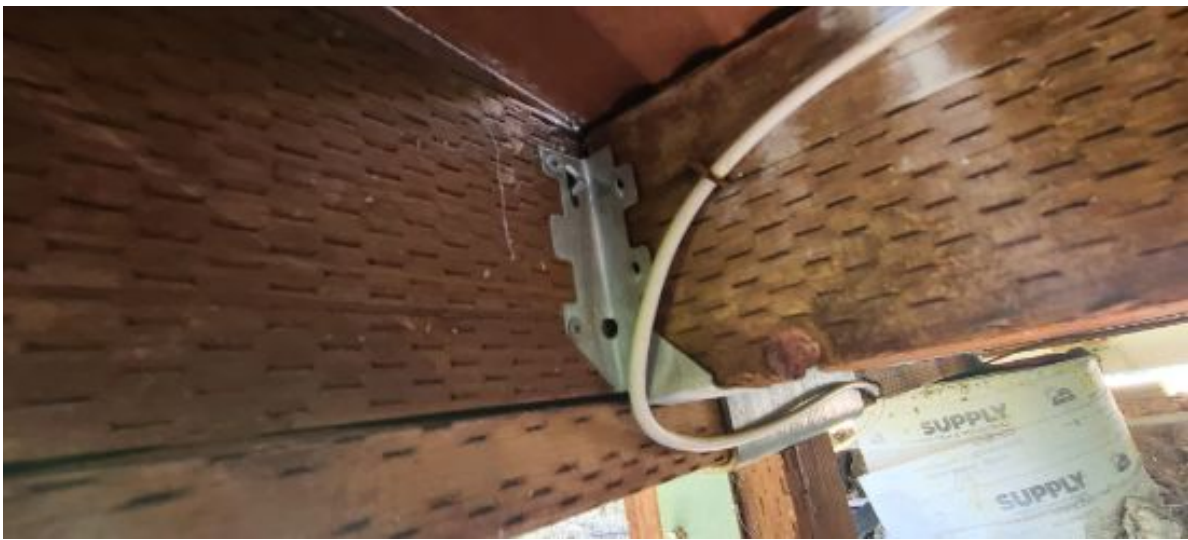
The framing is not done to current standards. There are also many missing screws or nails.

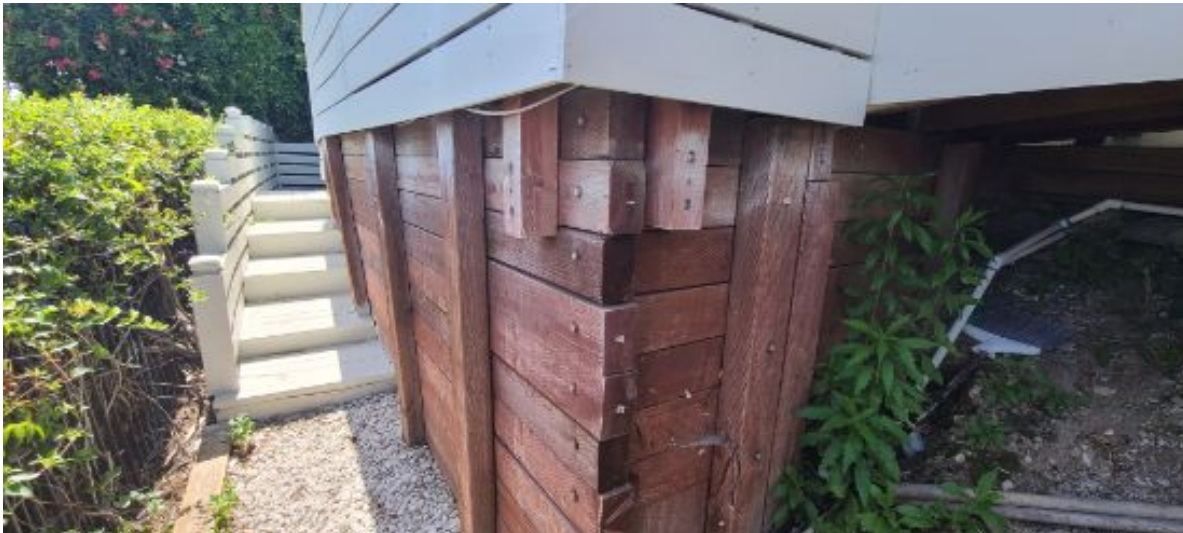
The rear wall was not been built to current standards.

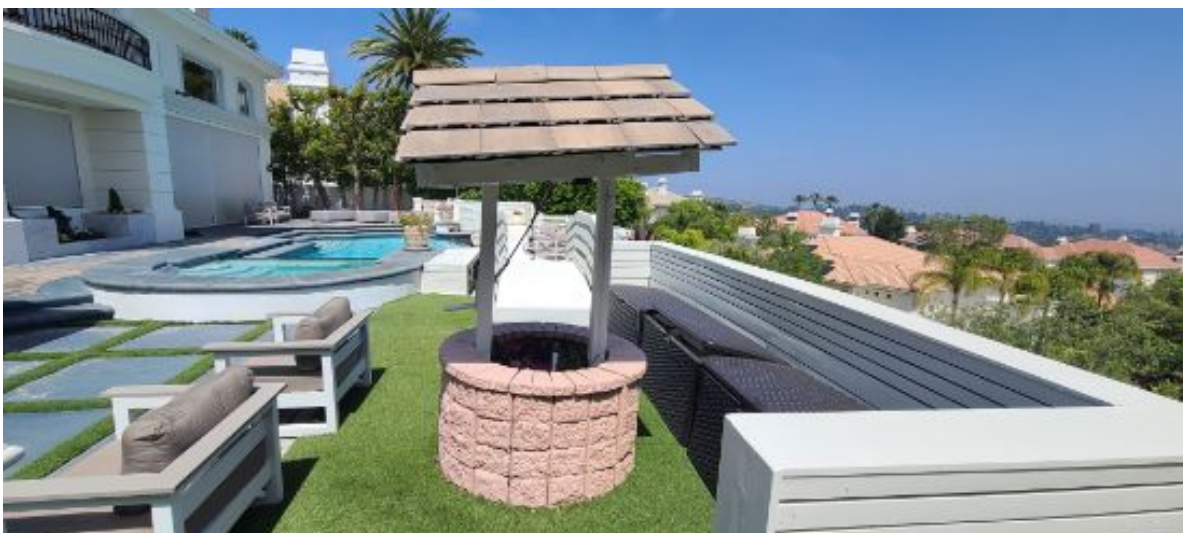
The well is loose and leaning

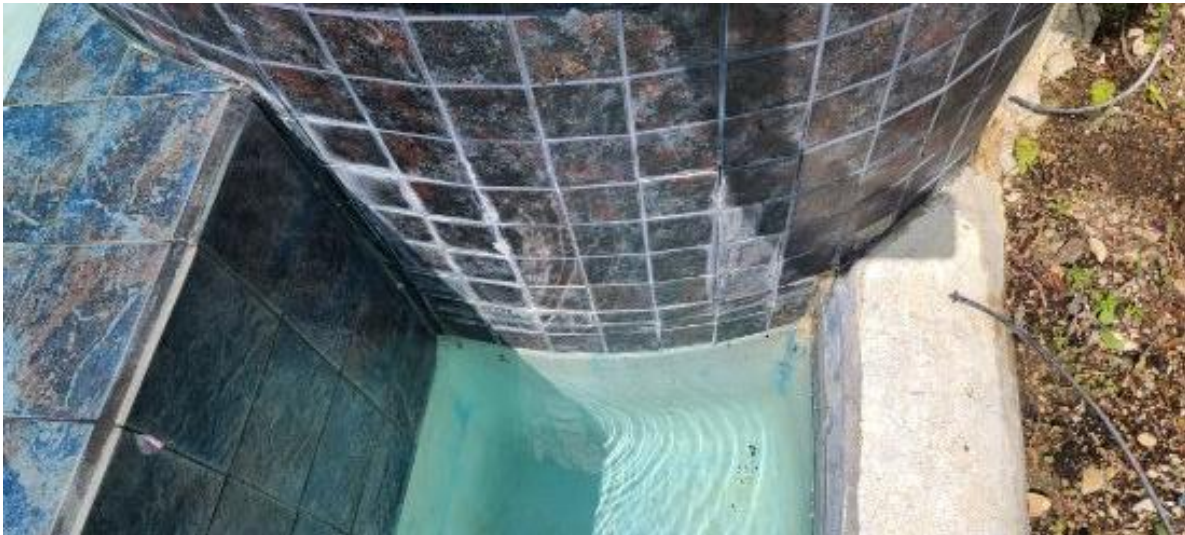
Deposits and worn grout at the tiles

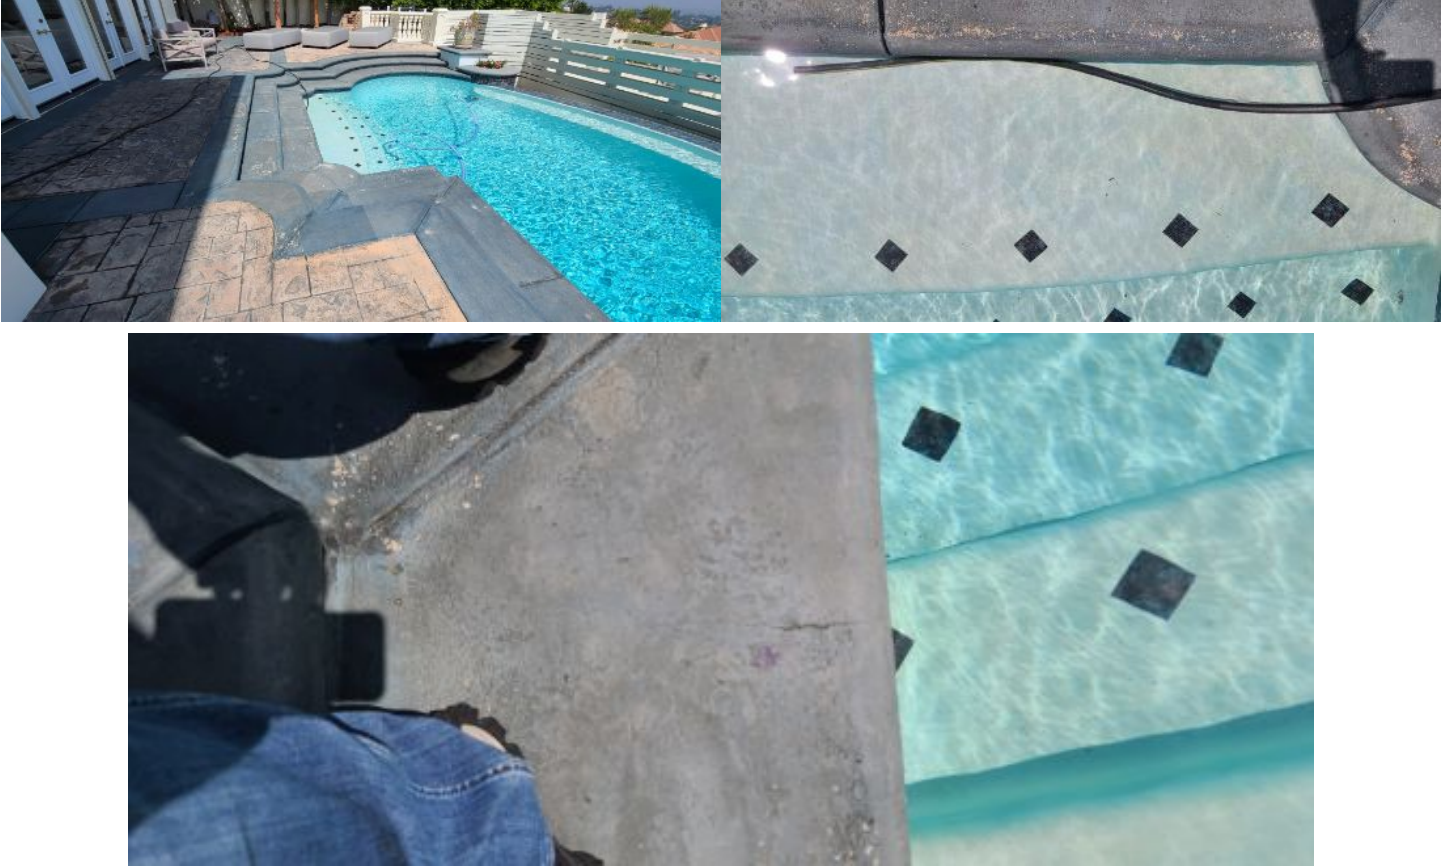
There are areas of cracked coping around the pool that should be sealed

The stain/finish is worn in areas.

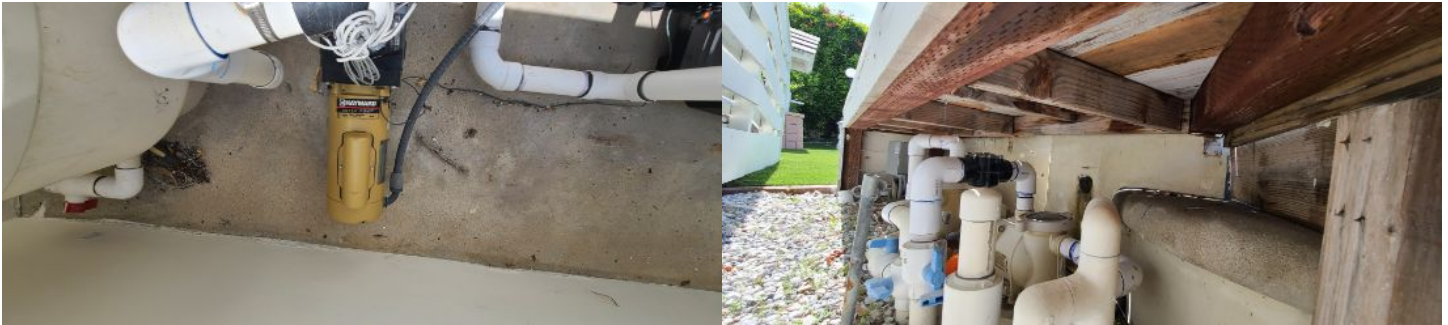
There is one pump at the filter and two under the wood cover near the pool. It is unknown why these are separated.

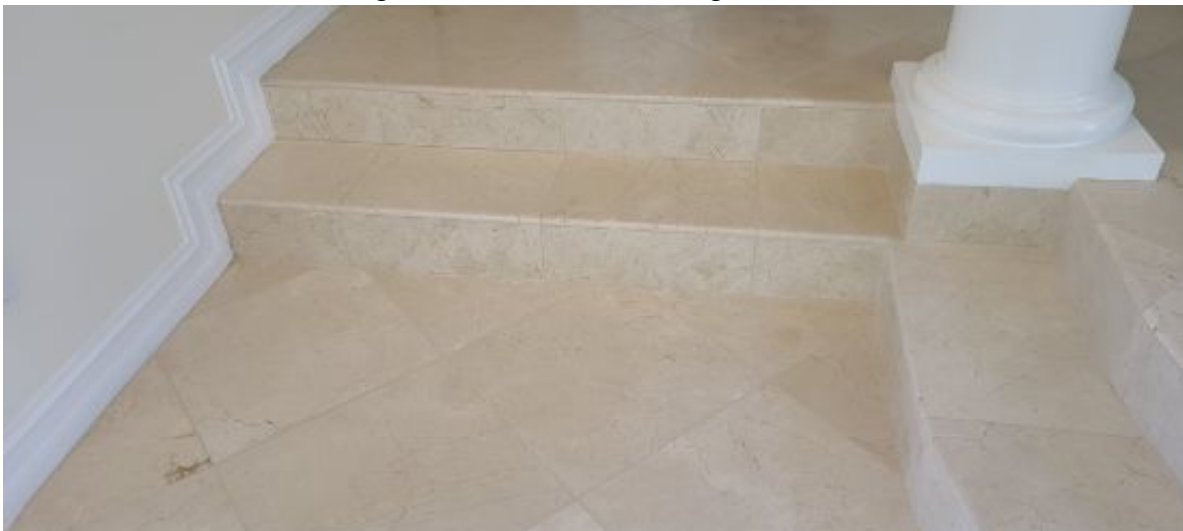
The risers of the stairs at the dining area have uneven heights

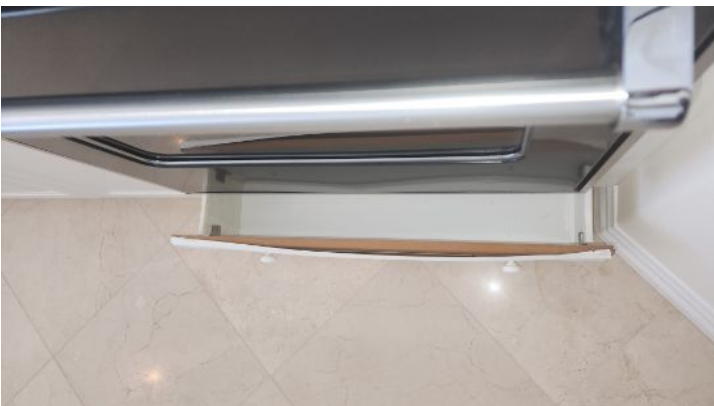
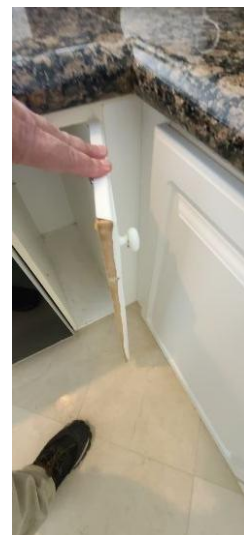
The vinyl wraps are peeling off in areas.

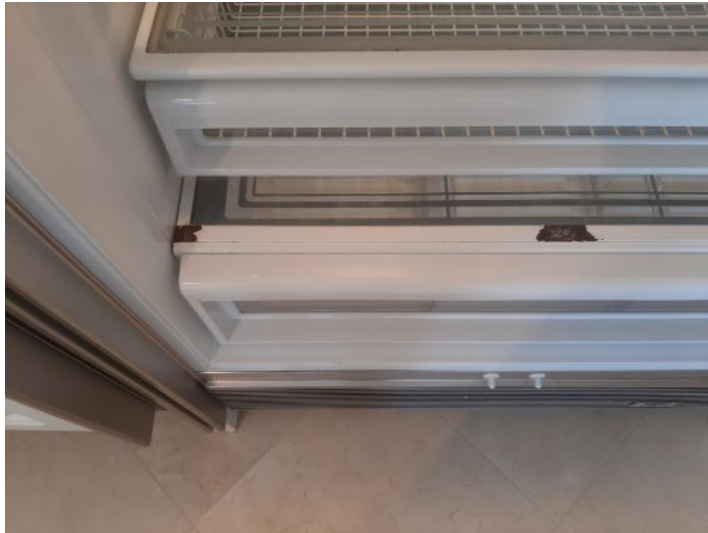
The bottom shelf is missing

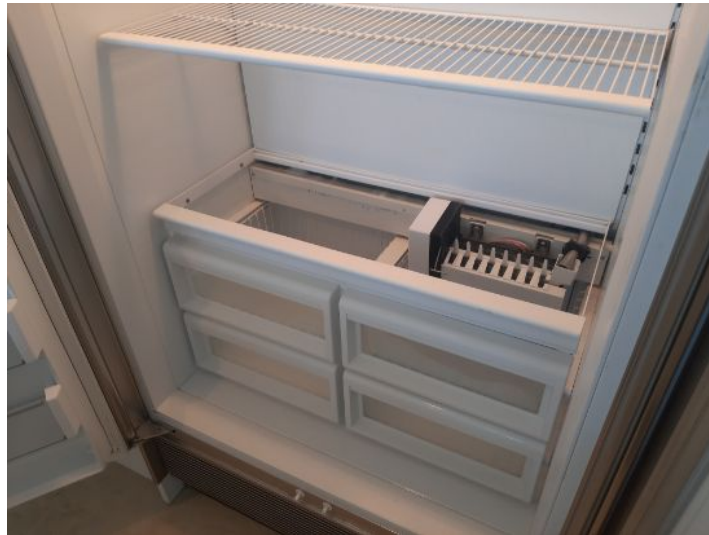
Missing bottom cover inside

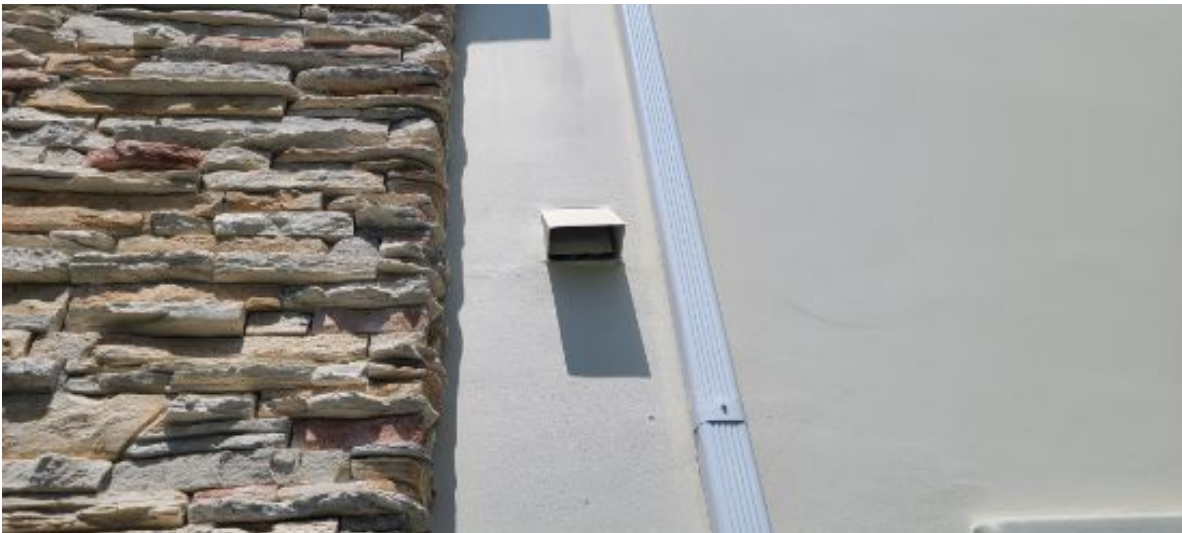
Dryer vent needs to be cleaned.

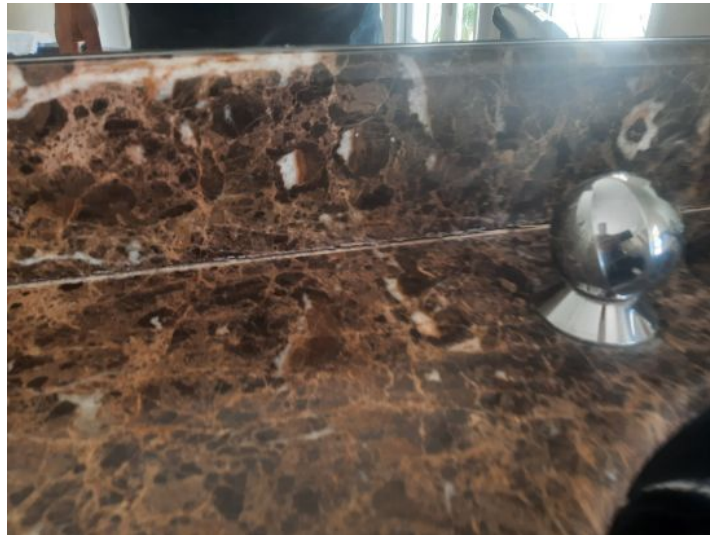
**The seam at the rear of the sink where the counter and back splash meet is deteriorate and needs to be resealed to prevent moisture intrusion to the area behind.**

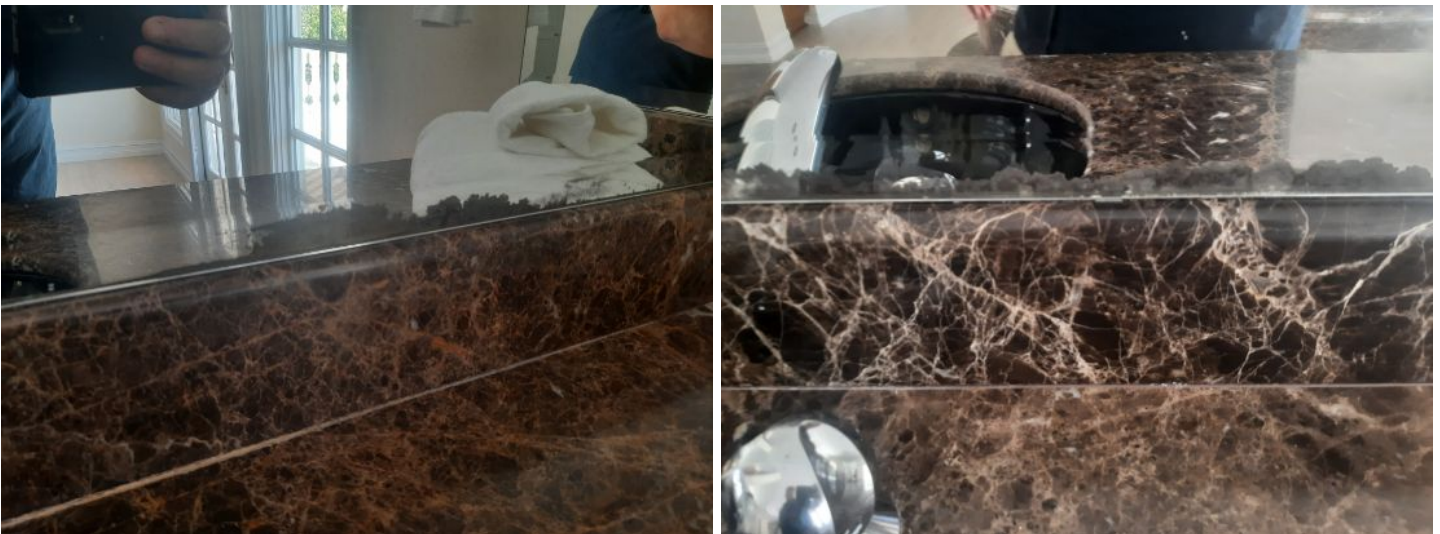
The mirror surfaces are deteriorated in areas.

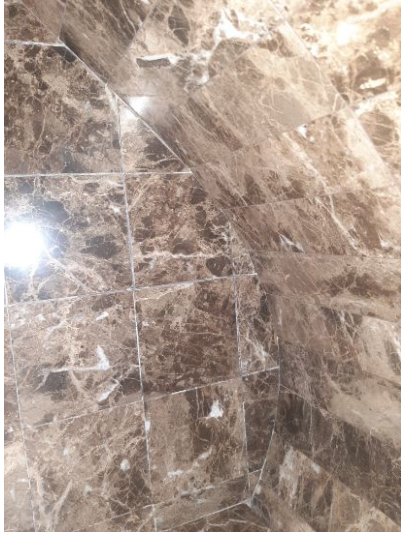
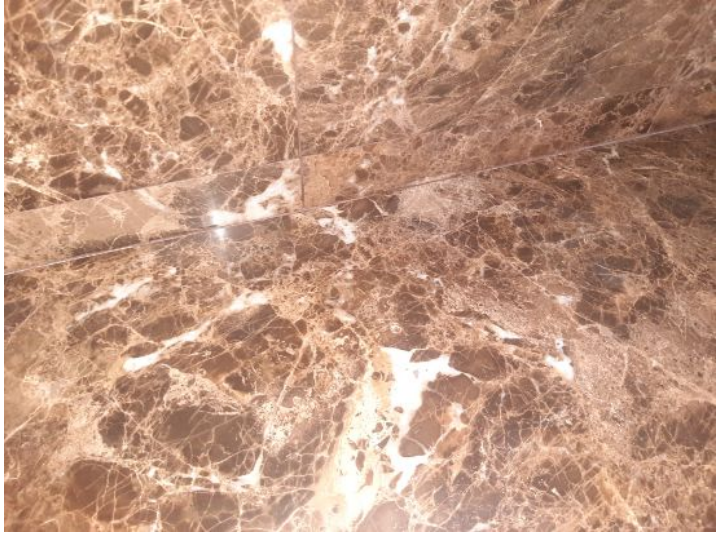
**The grout is missing in areas. This should be replaced.**

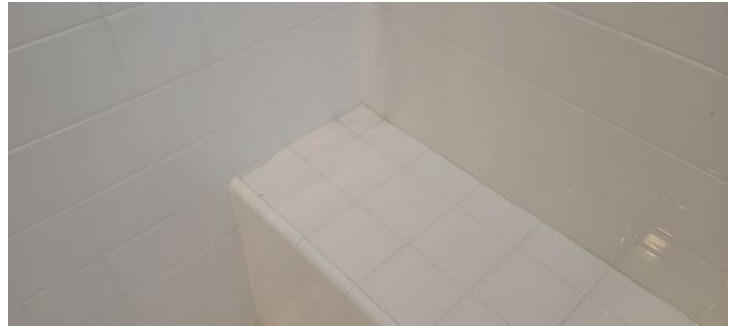
Some cracking grout noted

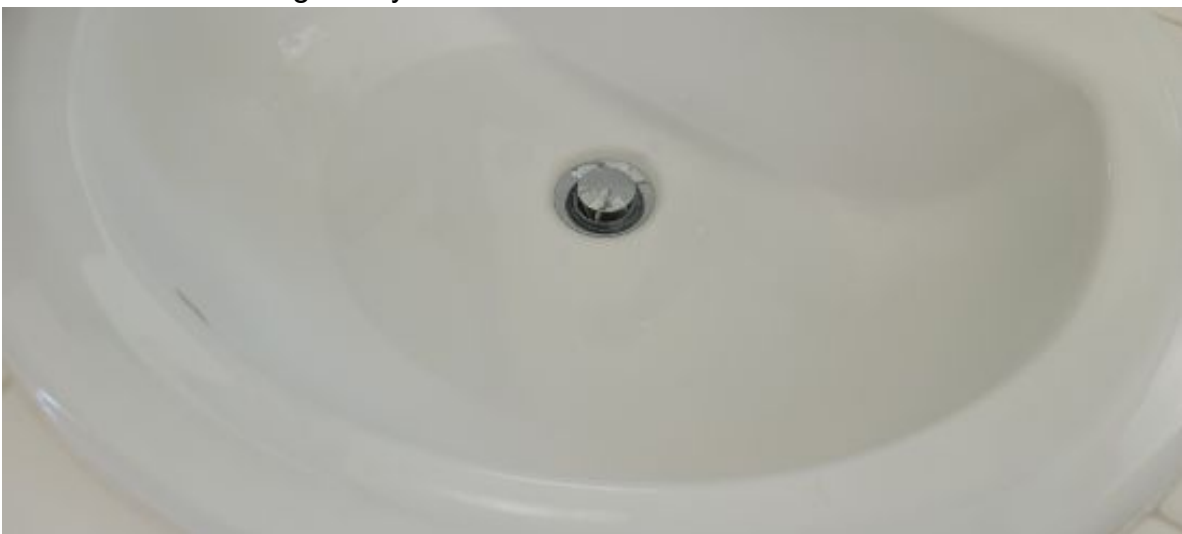
The bathroom sink is draining slowly.

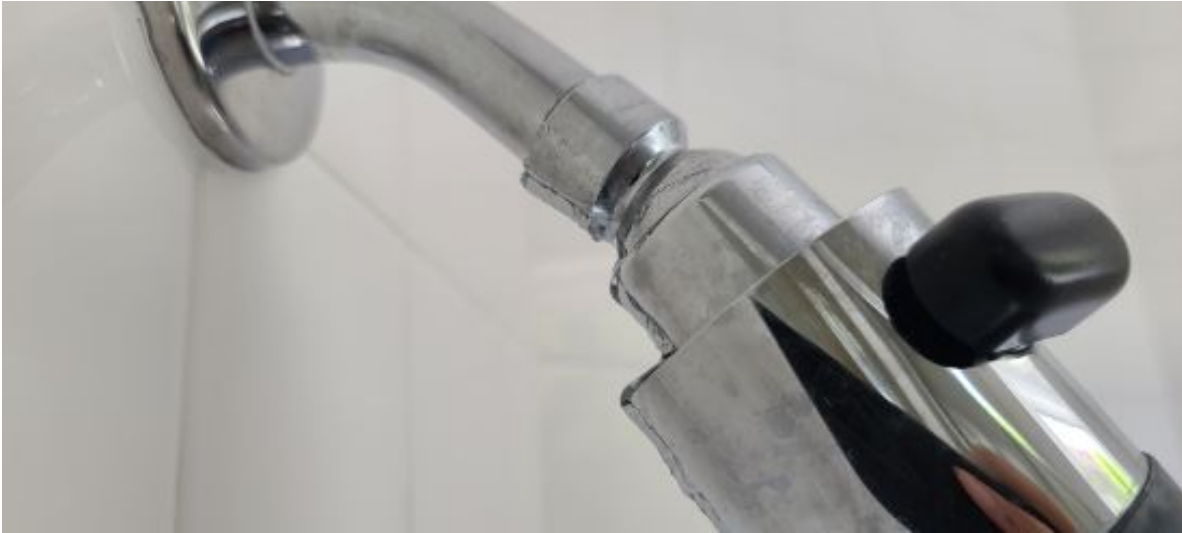
The shower head connections leak when in operation.

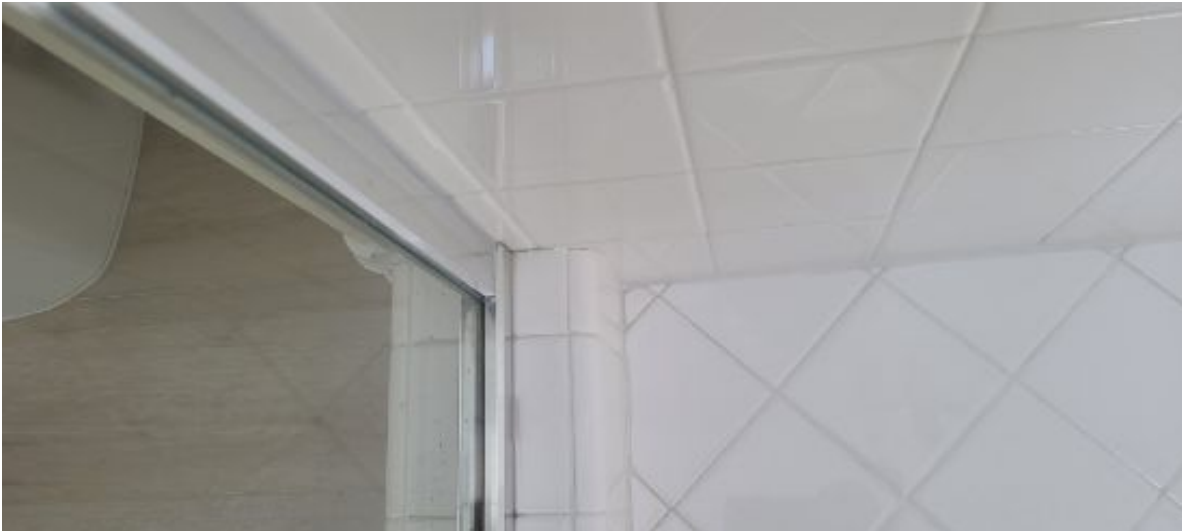
Cracking grout noted.
