# PROPERTY INSPECTION REPORT

**2320 Anywhere St, Los Angeles, CA, 90039**

**Inspector: Garrett Martell CMI**

**Date of Inspection: 6/6/2024**

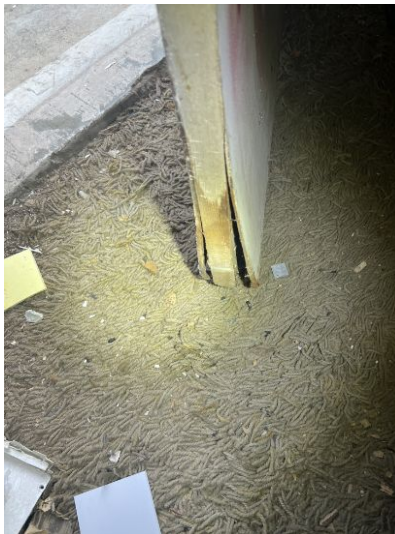
The storage doors need repair

Door to the crawl space

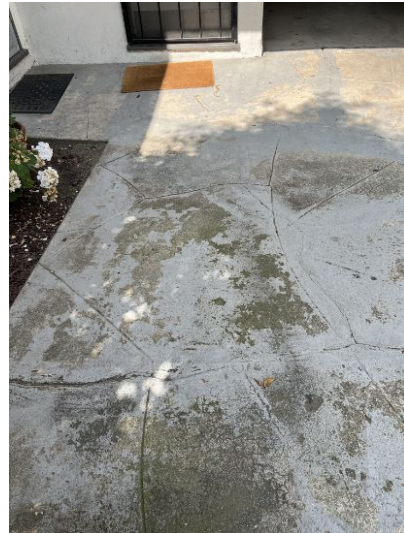
Area that may hold water due to lack of drainage.

There is no drainage in the courtyard. There are areas where the courtyard is not level, and will hold water. It is recommended to have drainage installed in this area.
