# PROPERTY INSPECTION REPORT

**3744 Main St, Tarzana, CA,**

**Inspector: Garrett Martell CMI**

**Date of Inspection: 5/31/2024**

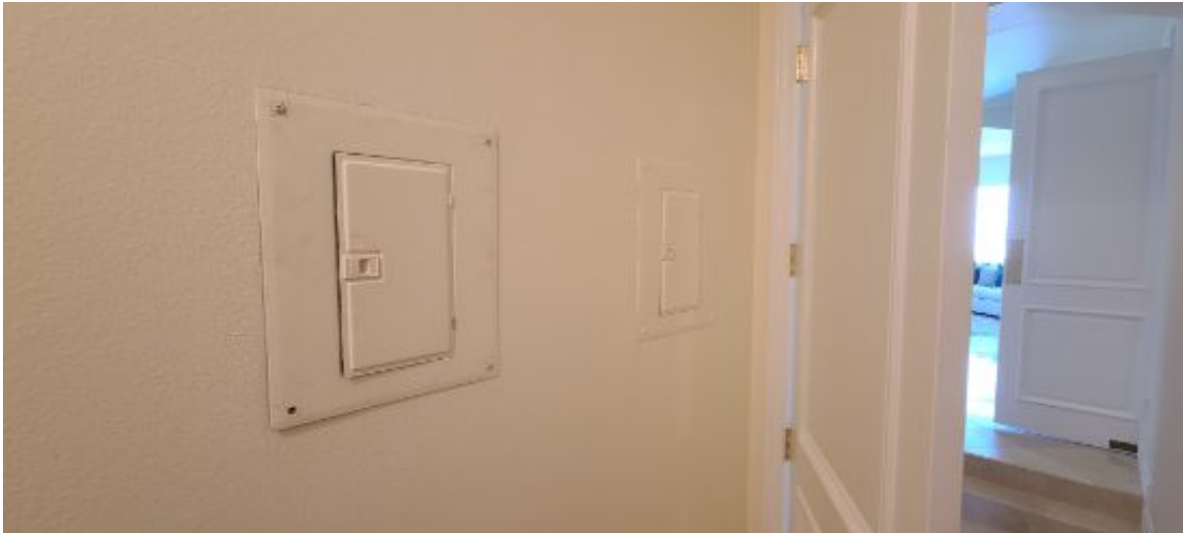
Two panels in this area

Missing screw

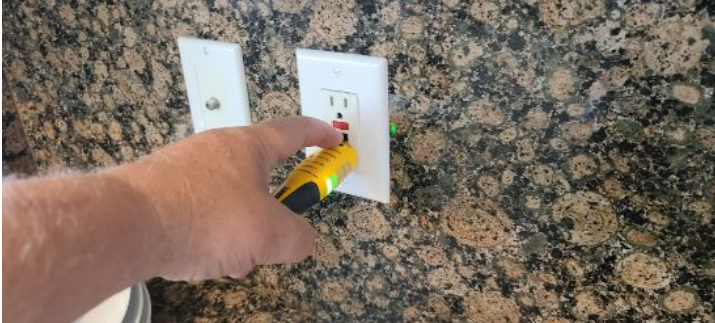
**The Ground Fault Circuit Interrupter (GFCI) outlet(s) in the kitchen did not work properly when tested.**

Kitchen outlets were not tripping

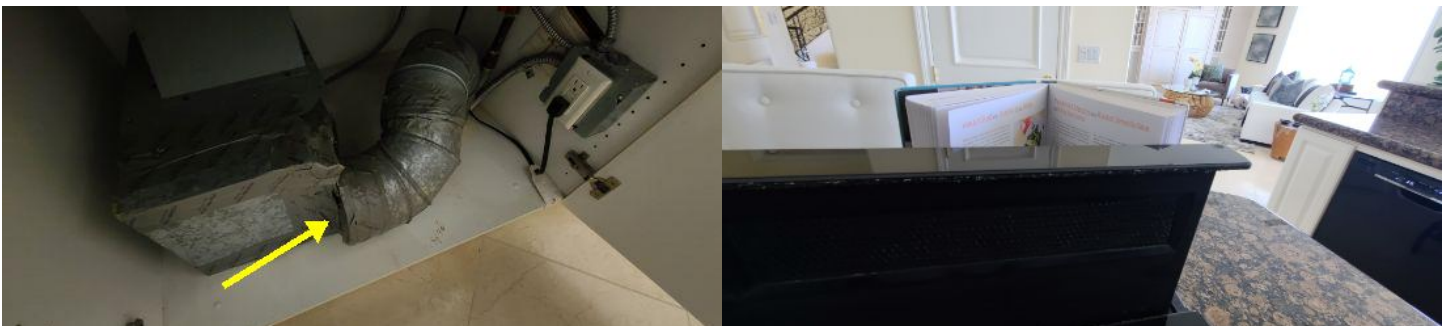
**The duct connection under the cooktop is installed such that it reduces the air draw through to the outside.**

Only 1/2 of the duct is connected.
