# PROPERTY INSPECTION REPORT

**2320 Anywhere St, Los Angeles, CA, 90039**

**Inspector: Garrett Martell CMI**

**Date of Inspection: 6/6/2024**

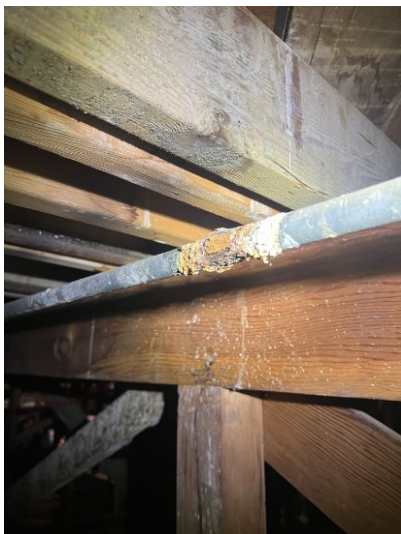
**The water lines are a combination of copper and galvanized steel piping. The original galvanized steel piping that is left in the system has rust and is showing deterioration. Some of the original pipes have been replaced with copper piping as they wore out, which is why there is copper in the system. The remaining galvanized steel pipes will need to be replaced in the future as they continue to wear out.**

Corroded

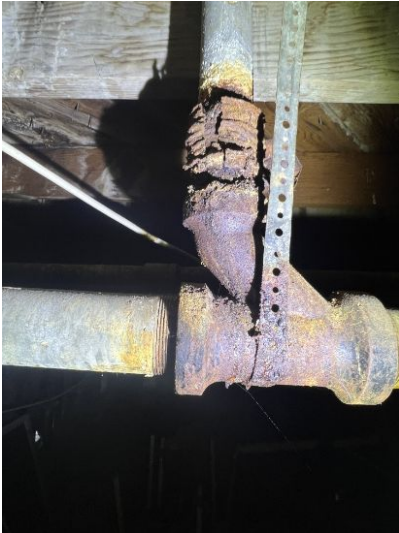
There are rusty areas on the exterior of the waste lines. It is not possible to tell when but they will need replacing in the future as they continue to wear out

Rust

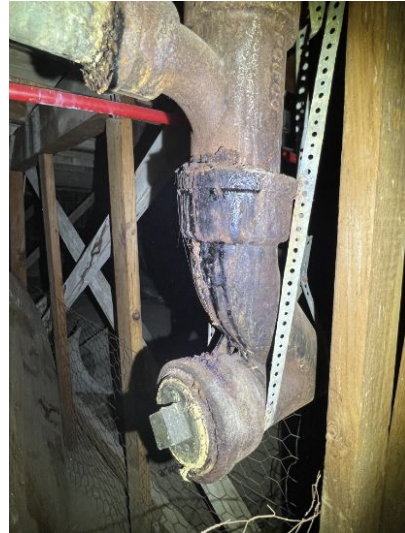
Rust

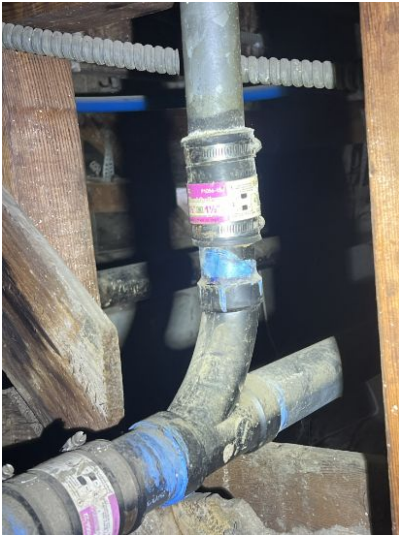
There are leaks in the waste pipes. These should be promptly repaired by a plumbing contractor

Leak - right crawlspace

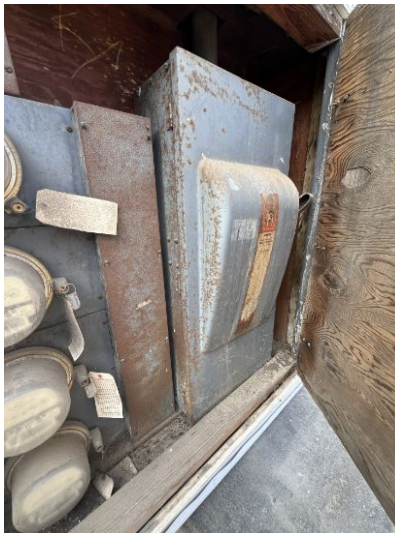
There is rust in and around the panel. This indicates that moisture has gotten into the panel.

The wood at the bottom prevents the main cover from being opened.

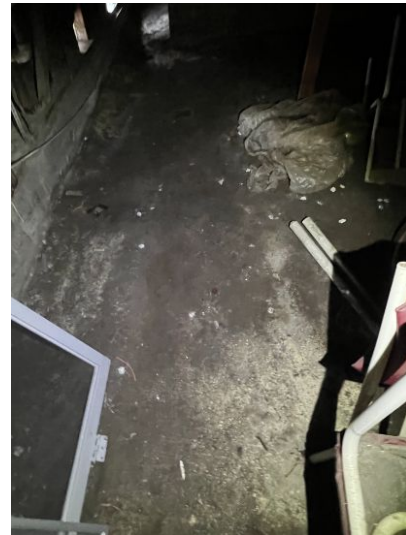
damp area

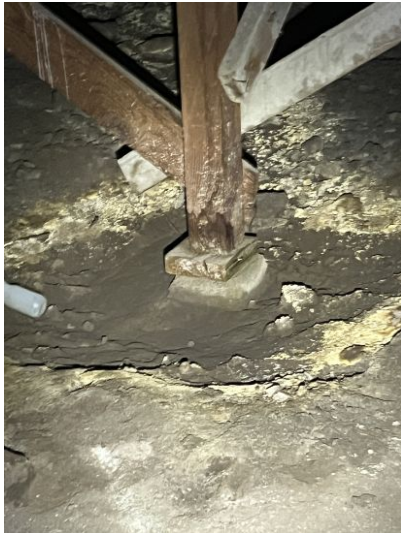
Wet area

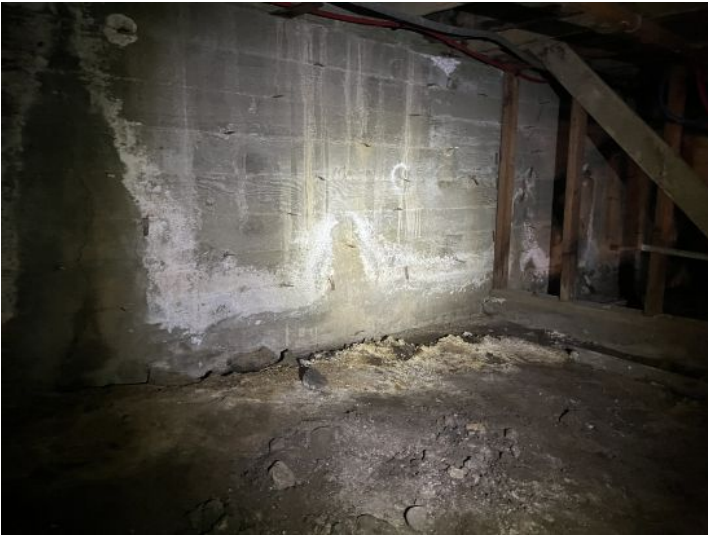
Efflorescence

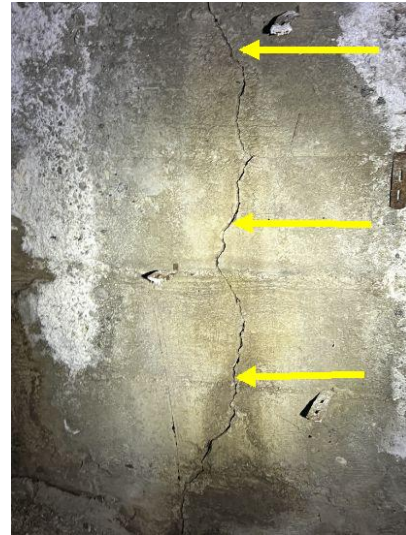
The concrete foundation has some cracking, but was in functional condition for a building of this age. It does not appear to be significant at this time. If a more detailed evaluation is required, it could be obtained from a structural engineer or foundation specialist.

Crack

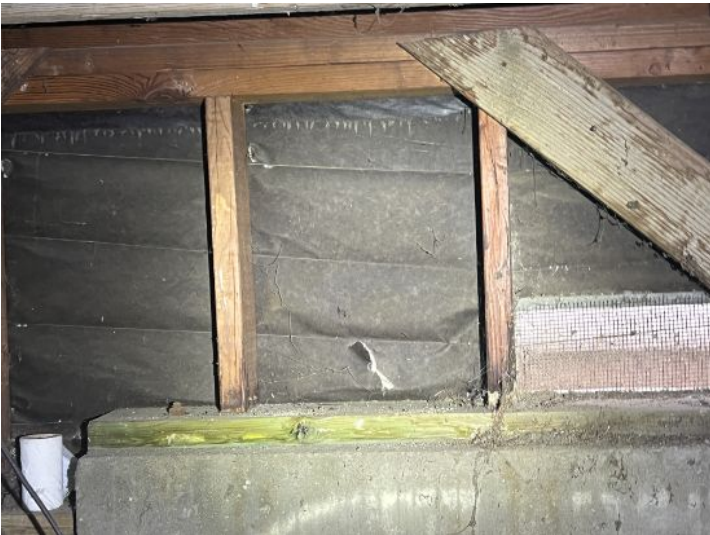
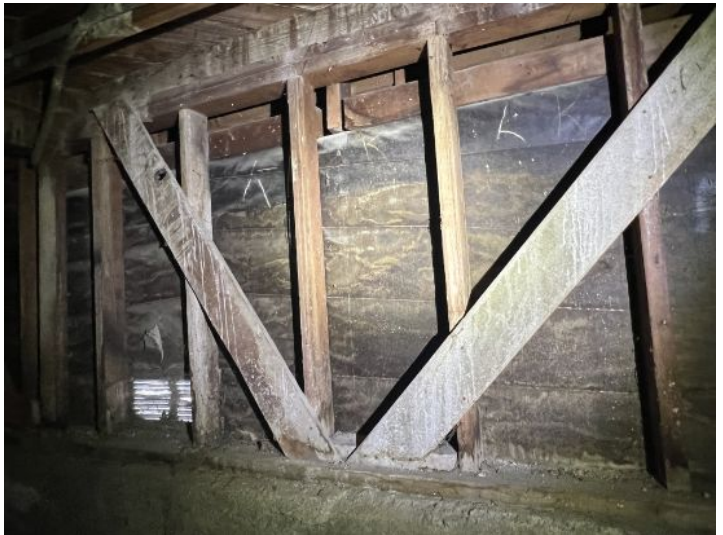
The cripple walls have not been strengthened with shear panels. Ideally plywood shear panels would be applied to a majority of the cripple walls. These are short walls between the foundation and the under side of the house framing. Shear panels would help prevent an earthquake from shifting the structure at this junction.

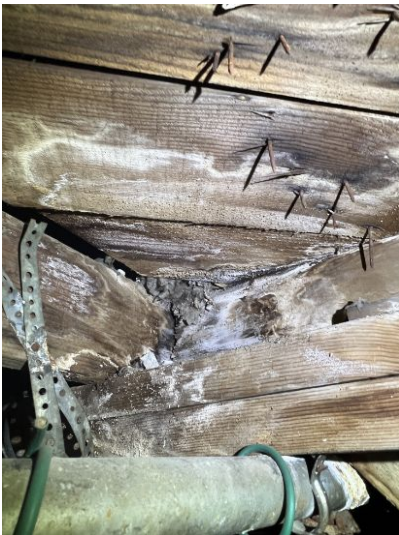
There are damaged and deteriorated areas of floor framing.

Staining & deteriorated

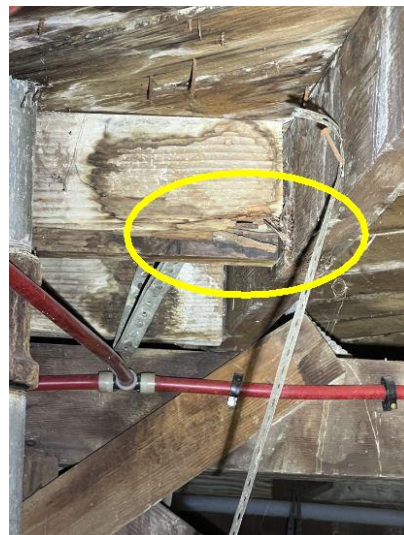
Deterioration

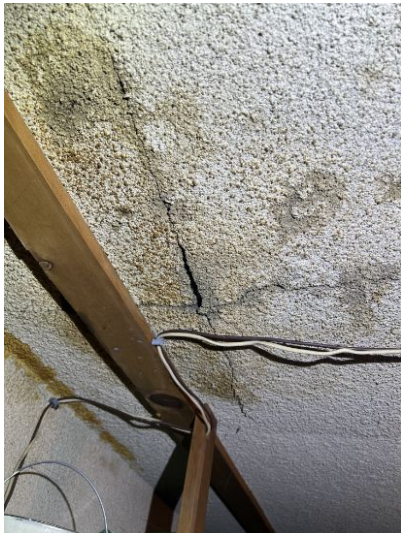
Small room next to the entry stairs - stains on the ceiling

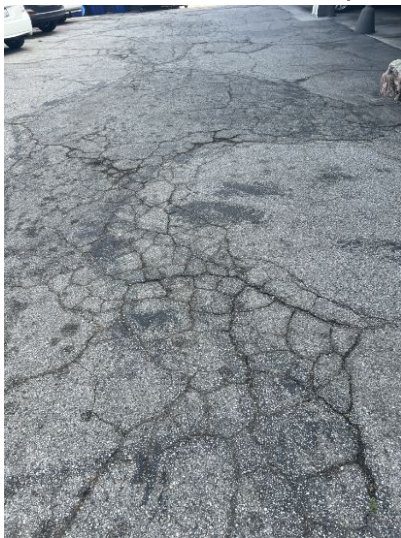
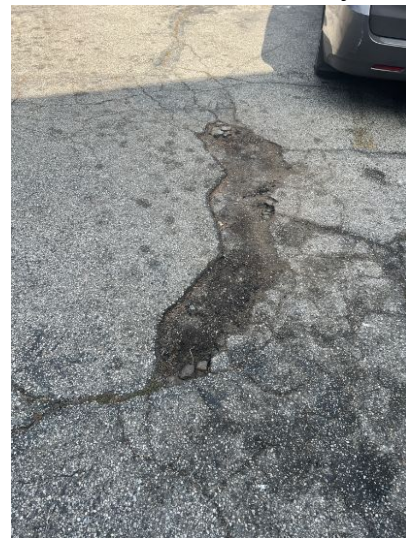
There are deteriorated areas of asphalt due to wear and tear of the surface over the years.

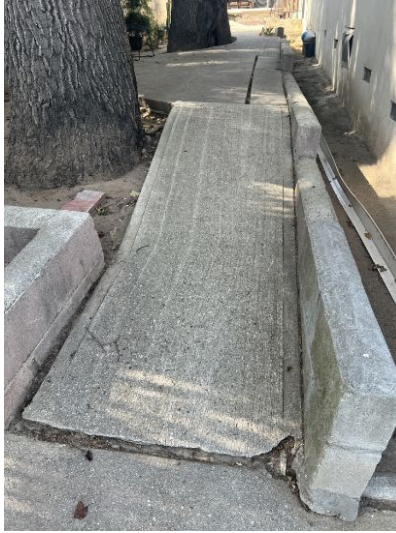
There are raised and shifted areas of the walkways that appear to be a trip hazard.

Slopes

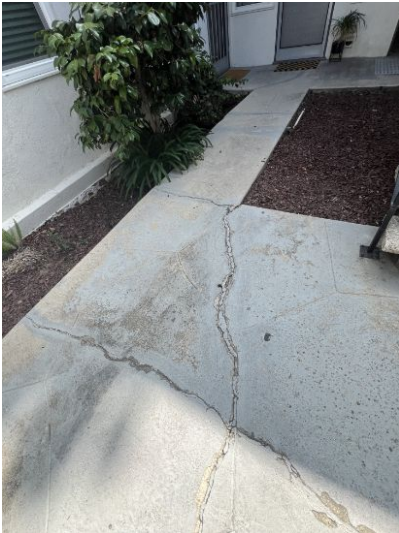
There are cracks and shifted areas of concrete that are typical for the age and type of construction.

Cracking

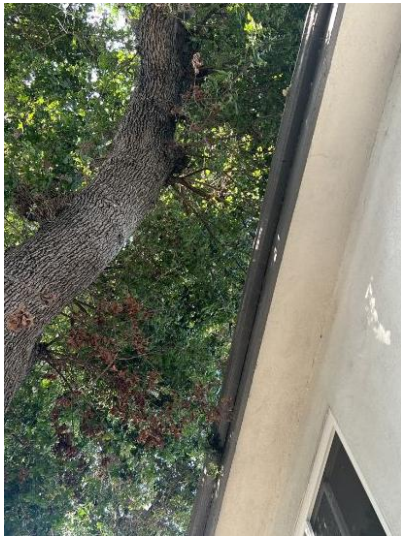
There are trees planted close to the structure with branches that are overhanging/close to the roof. These may need to be trimmed back at times.

The tree is old and deteriorated. Consult an arborist

Trees close roof:

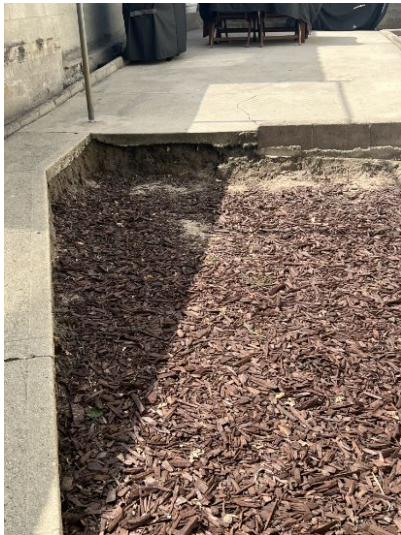
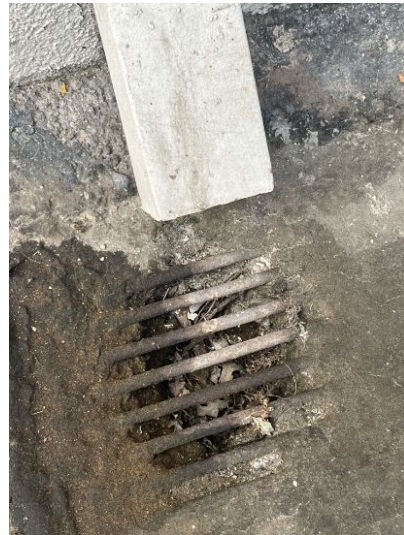
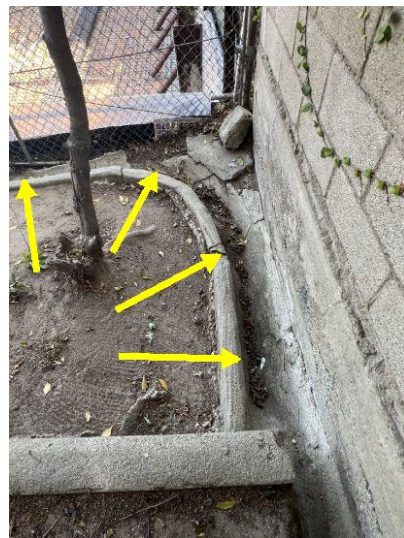
There is evidence of improper drainage on the site causing erosion of the soil in areas.

It is advisable to have a Geologist fully examine the site and make any recommendation concerning erosion and drainage

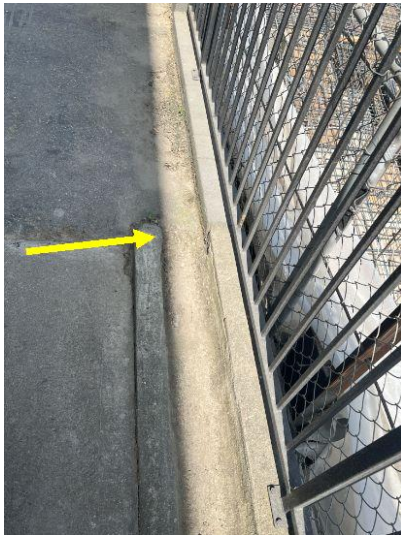
It's noted the properties behind the subject property have drainage pipes that empty into a culvert drainage ditch at the rear of of the subject property. This ditch runs from the rear, down the left side of the property and ends at the driveway. It is recommended to keep this culvert clear .

Culvert at the rear, going to the front

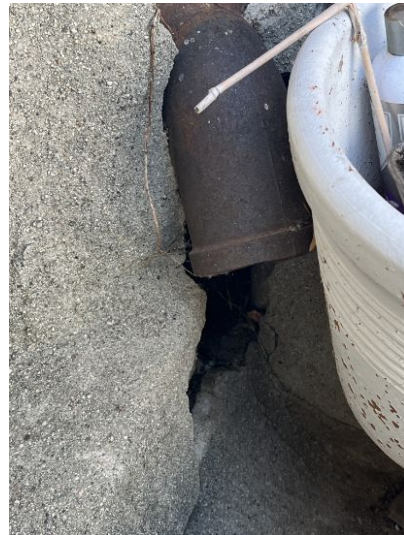
Culvert ends

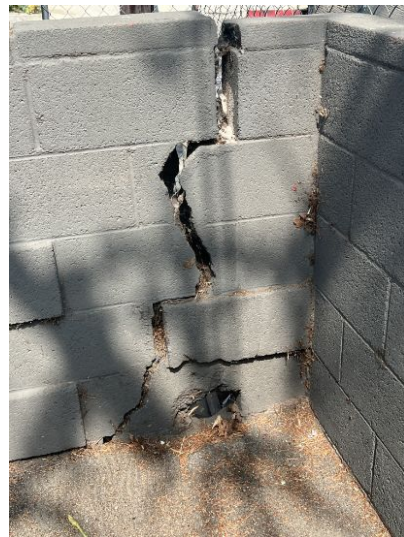
The block fencing is damaged in areas - front

Step cracking

Front

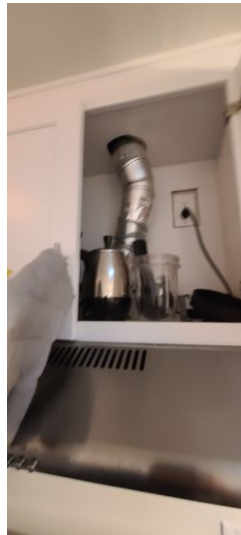
The duct for the exhaust is smaller than the outlet which may reduce air flow.

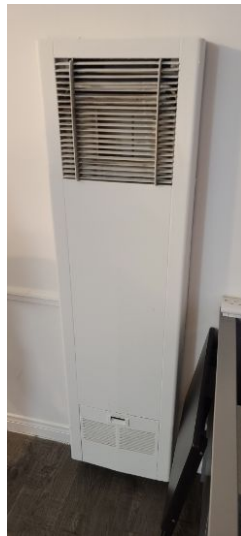
The furnace is very old and aged. While still working at this time, it is well past its expected life span

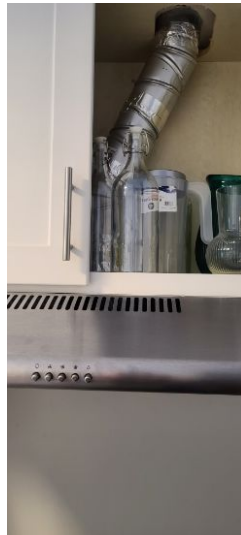
The vent duct is too small.

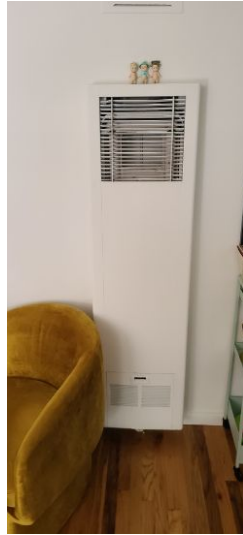
The furnace is very old and aged. While still working at this time, it is well past its expected life span

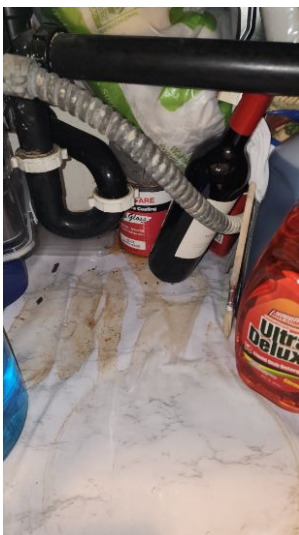
Drain leaks

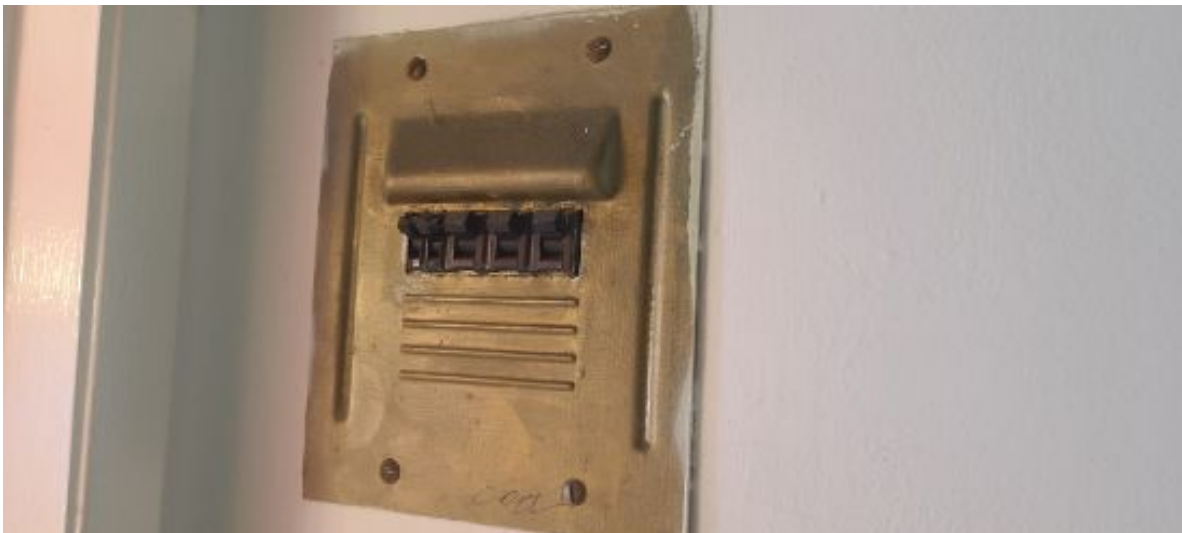
There are no **GFC** outlets in areas that require them, such as the kitchen, bathrooms or any area exposed to a water source.

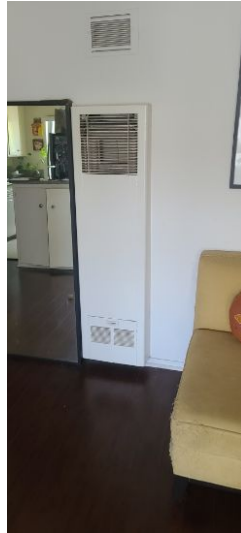
The furnace is very old and aged. While still working at this time, it is well past its expected life span

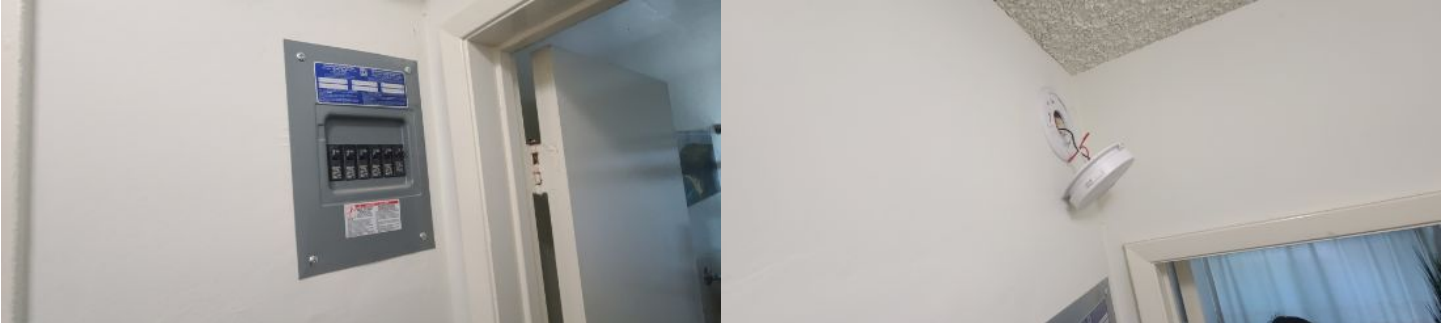
Serviceable - newer sub panel in this unit

SMOKE DETECTORS

There are hanging smoke detectors in areas

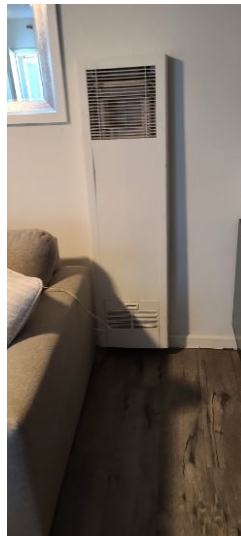
This is a gas wall heater

The furnace is very old and aged. While still working at this time, it is well past its expected life span

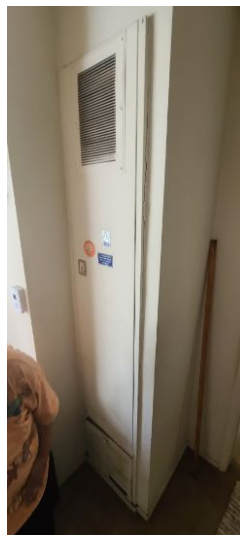
This is a gas wall heater

The furnace is very old and aged. While still working at this time, it is well past its expected life span

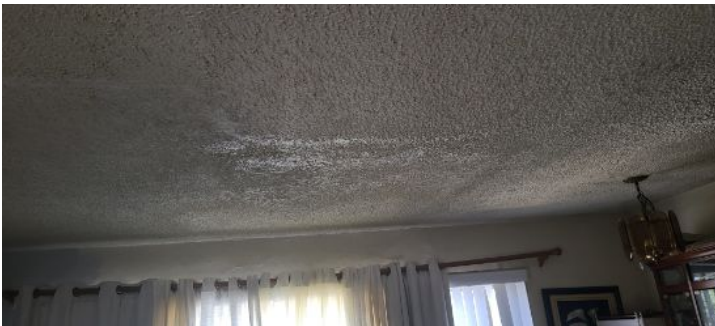
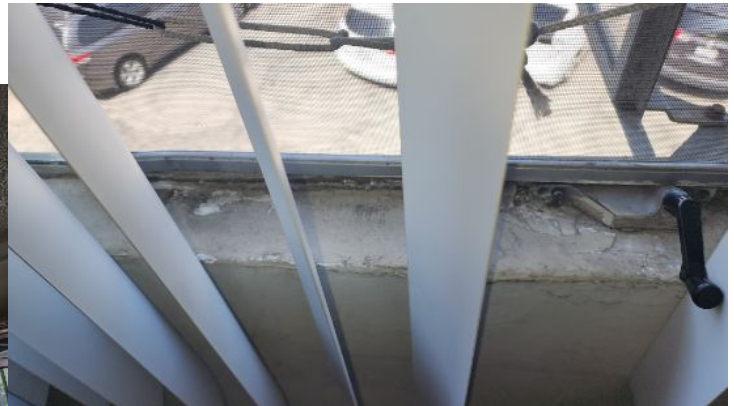
## Walls and Ceilings

There are areas of past patching and painting. The seller could be consulted.

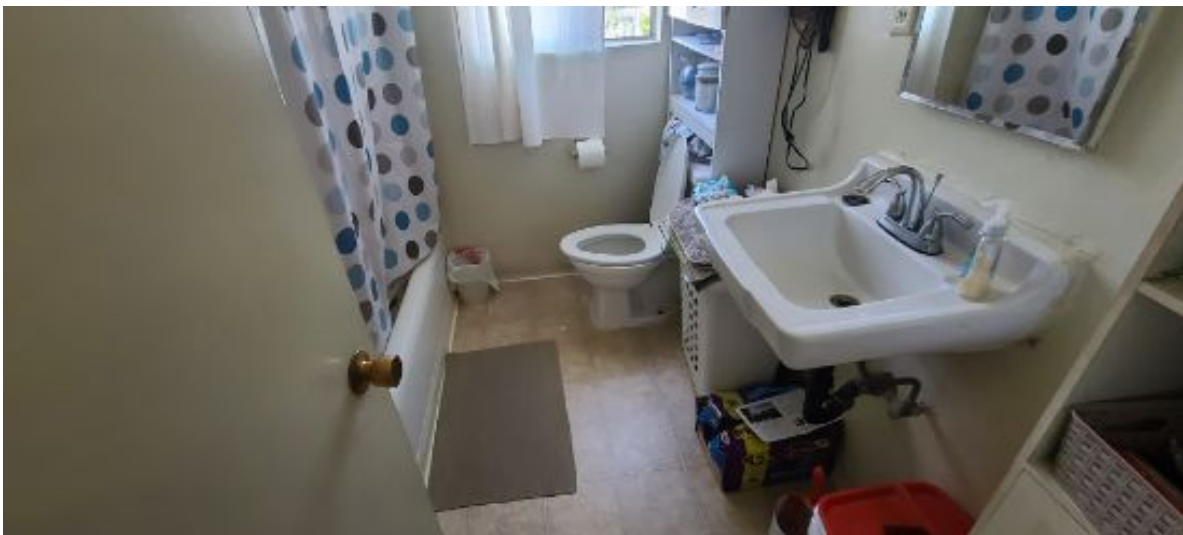
### Walls/Ceilings Floors

The duct for the exhaust is smaller than the outlet which may reduce air flow.

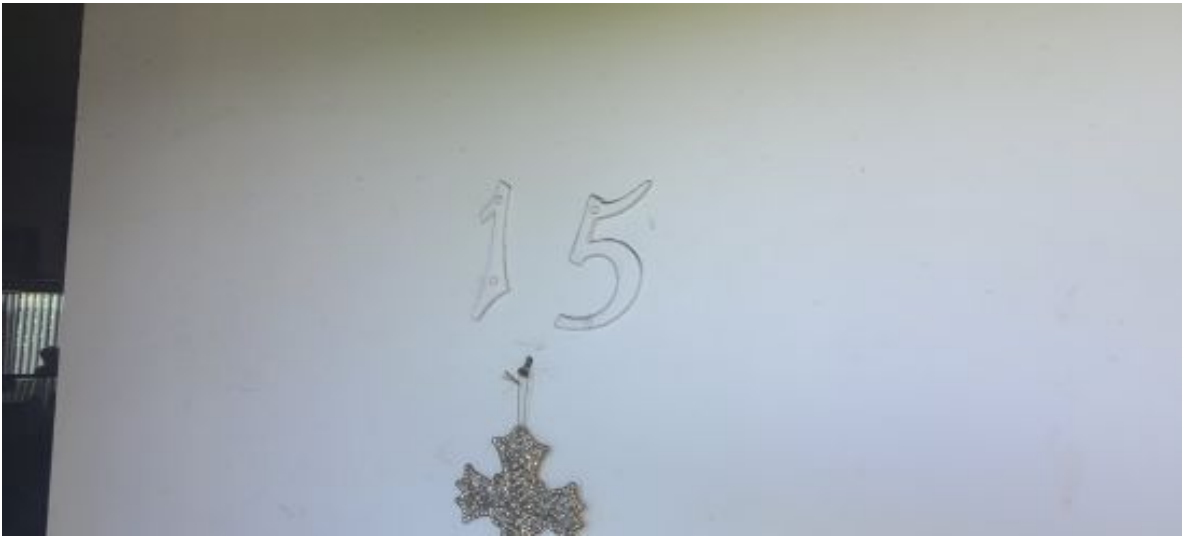
There are areas of stress cracks in the walls

There are areas of stress cracks in the ceiling

There are areas of damage on the ceiling

There are areas of damage on the walls

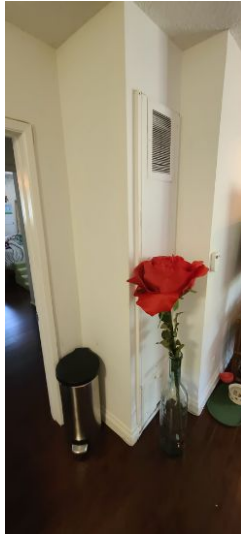
This is a gas wall heater

The furnace is very old and aged. While still working at this time, it is well past its expected life span
