# PROPERTY INSPECTION REPORT

**3744 Main St, Tarzana, CA,**

**Inspector: Garrett Martell CMI**

**Date of Inspection: 5/31/2024**

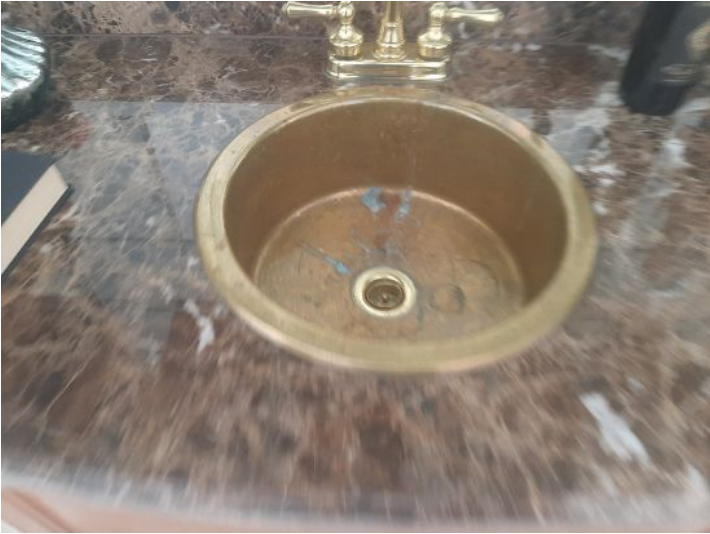
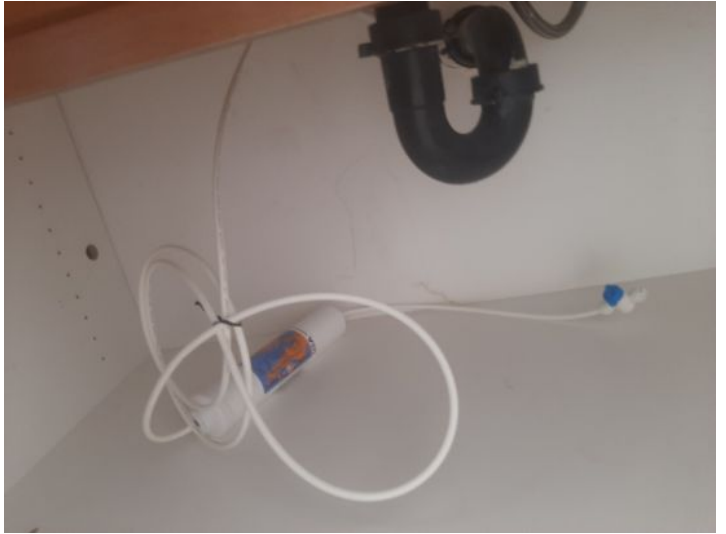
The water was turned off to the bar sink in the master bedroom

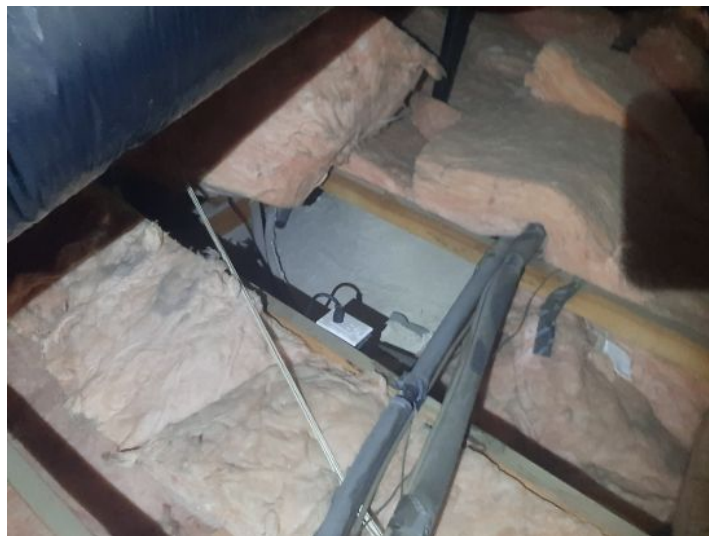
The insulation has been disturbed and good coverage is no longer present in some areas of the attic. Ideally, there would be 8-12 inches of insulation in the attic for improved energy efficiency of the home.

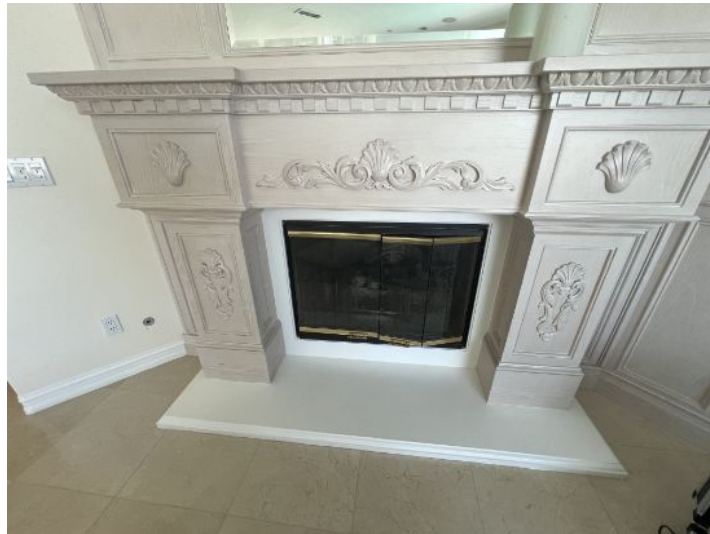
There are stains near the top.

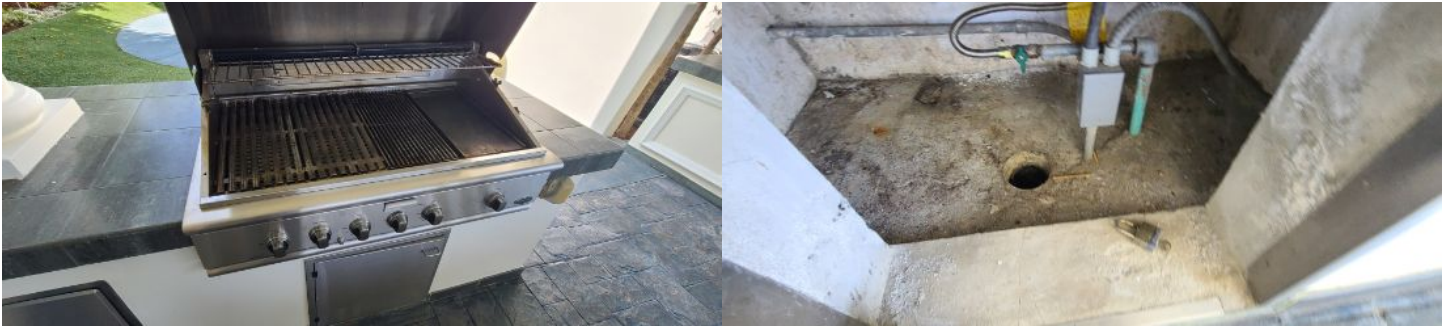
The barbecue did not operate when tested.

The gas was turned off

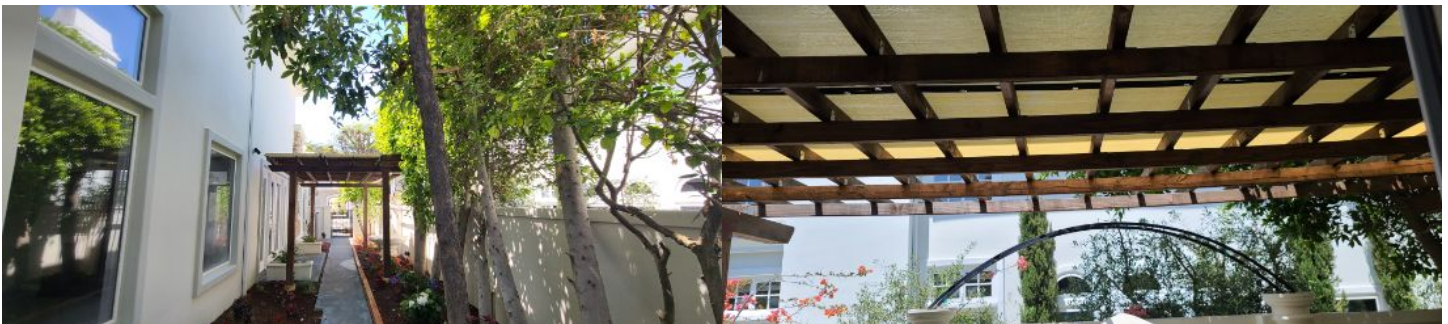
The pergola at the left side is not built to current standards. The spacing is much too wide for 2x4 top chords

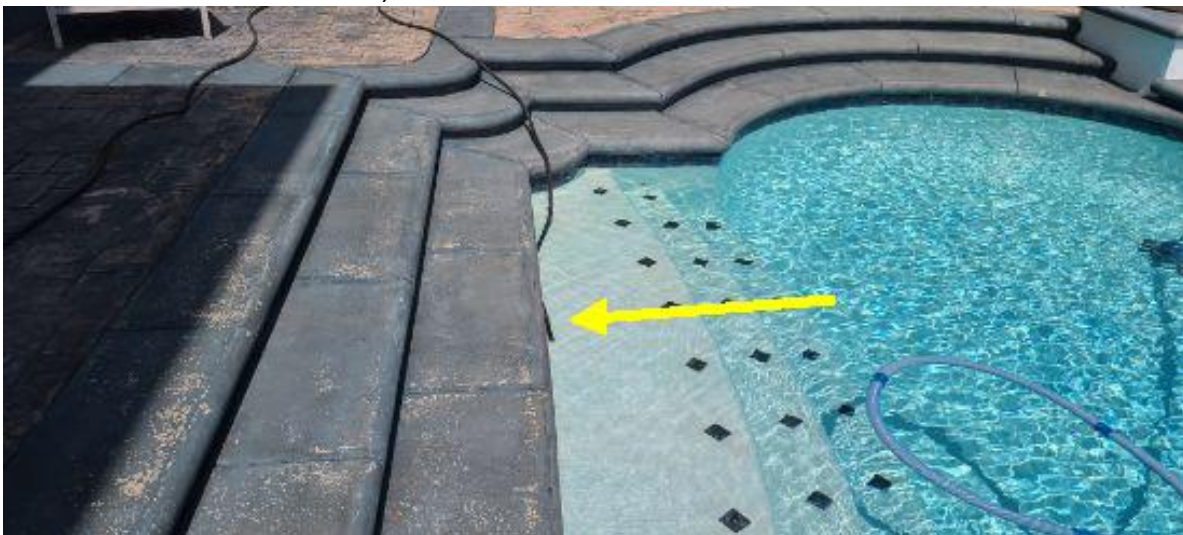
No auto filler

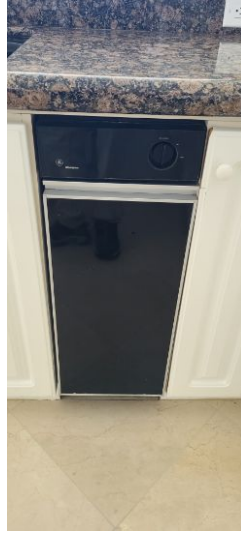
The trash compactor is not working properly at the time of inspection.

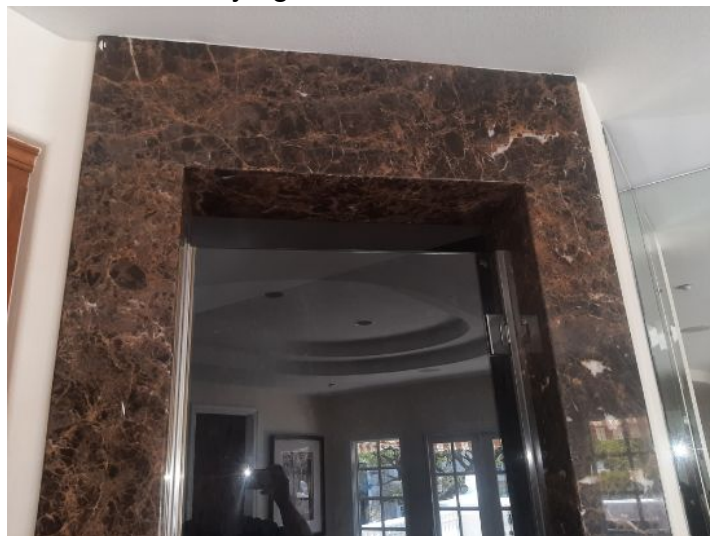
The door will prevent the shower from drying when closed. It should be left open after use.
